**USE OF BLUE LIGHTS ON PAVING
EQUIPMENT IN WORK ZONES**

Final Report

ODOT ORDER NO. 19-03

Oregon Department of Transportation

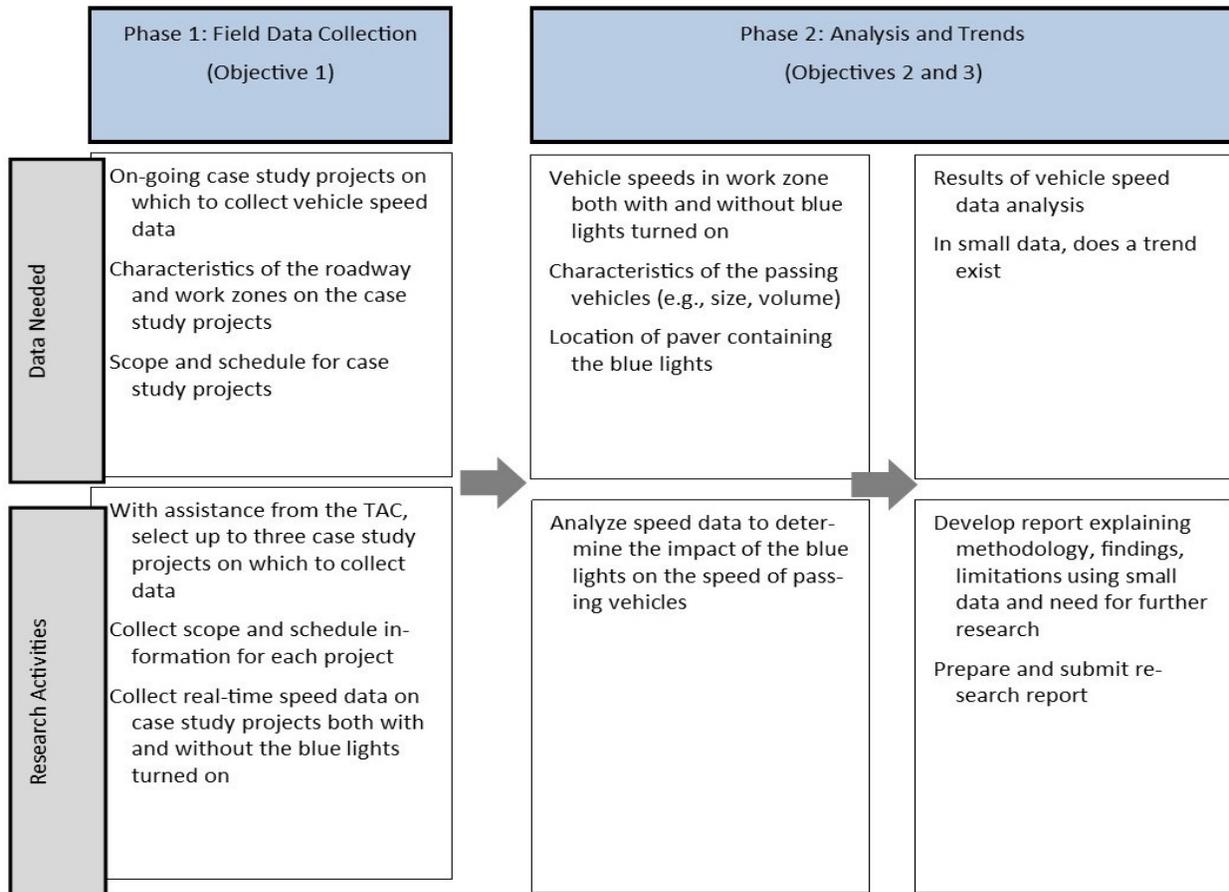
Figure 1.1: Research plan for data and research activities

The research plan for meeting the study objectives is illustrated in Figure 1.1. The overall plan contains two overarching phases: Phase 1 to collect speed data from on-going paving operations (Objective 1), and Phase 2 to analyze the data, identify trends, and develop recommendations for ODOT (Objectives 2 and 3). The specific tasks in each phase are described in more detail in Figure 1.1 and in Section 3 of the report.

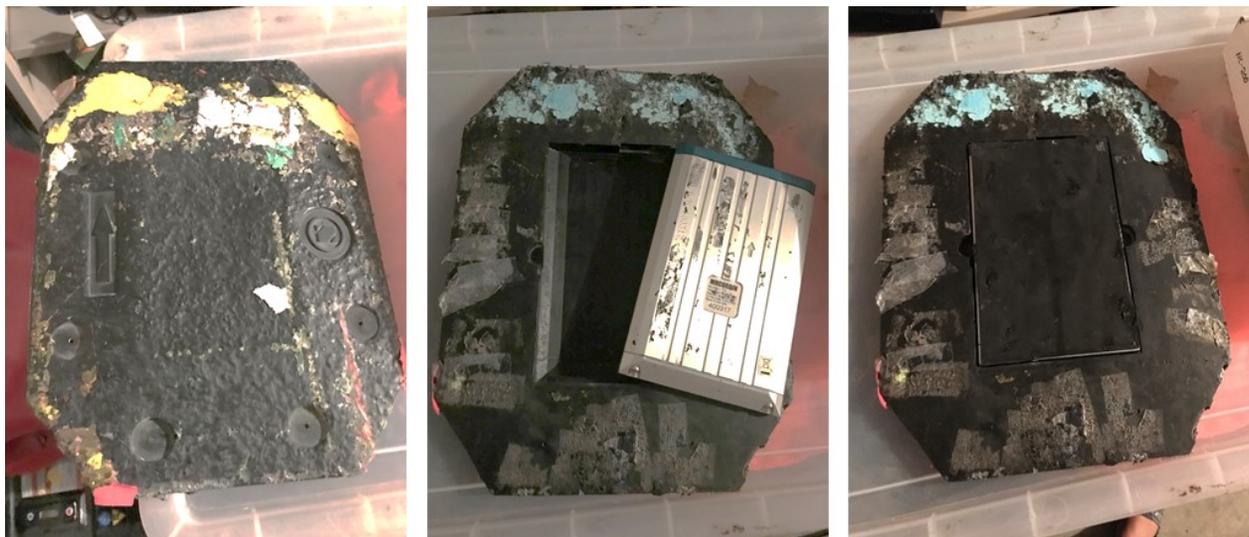
Figure 3.3: Components of traffic sensor

For their placement on the roadway, a cover made of visco-elastic material is placed over the sensors as a protective buffer from vehicle impacts. To adhere the sensors to the road surface, adhesive tape is then placed over the cover. First figure shows an example of the type of cover used along with the sensor. In Figure 3.4, provided by MH Corbin, a cross-sectional view of the NC-350 set up can be observed.

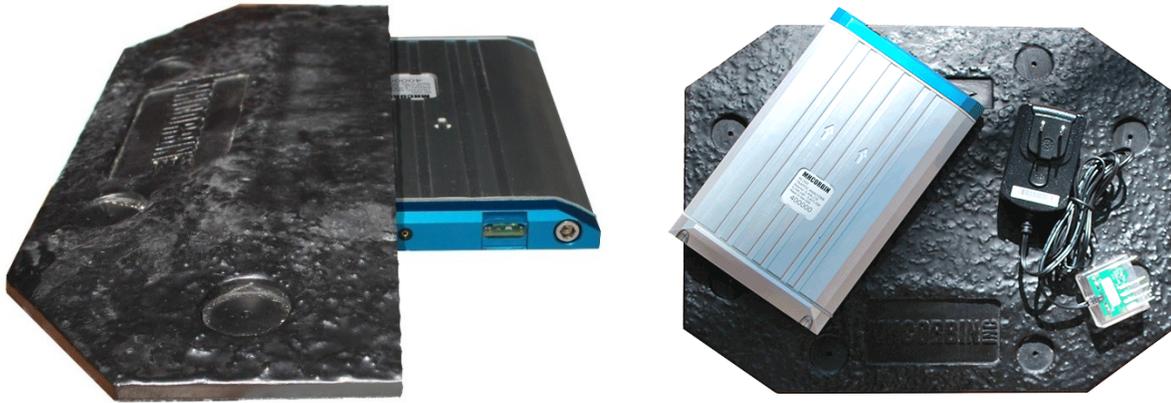
Figure 3.4: NC-350 portable traffic analyzer (M.H. Corbin 2017)

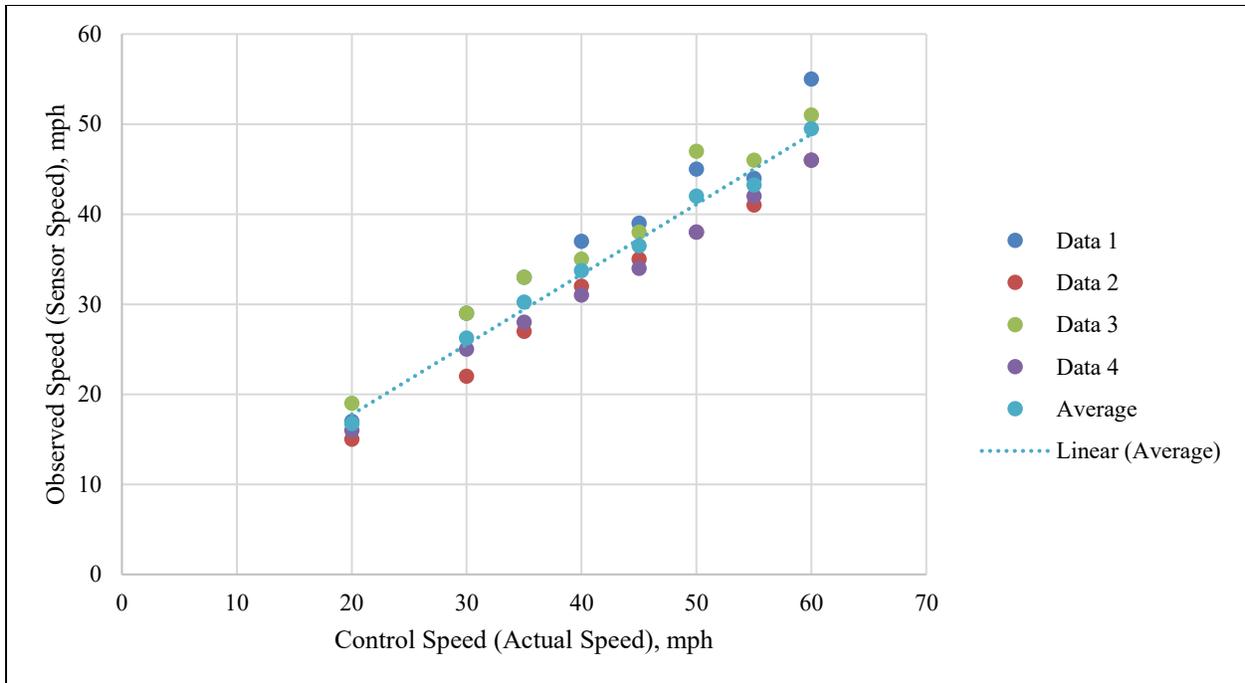
Figure 3.5: Linear regression of calibration data for traffic sensor 101

A calibration procedure was implemented to confirm the accuracy of the recorded vehicle volume, speed, and classification values from each sensor. In the controlled environment of the Corvallis Municipal Airport, sensors were placed on a roadway and used to collect data relative to multiple vehicles passing over the sensors at preselected speeds. Control speeds of 20, 30, 35, 40, 45, 50, 55, and 60 mph were selected. Test vehicles were driven over the sensors four times at each selected speed after which an analysis using linear regression was performed. In this regression, control speed was considered an independent variable and the observed speed recorded by the sensor was considered a dependent variable. This analysis led to an equation relating the recorded speed to the actual speed. However, while using this equation to calibrate the case study project data, the equation was solved to determine the x value as y is the observed speed value recorded by the sensor. Figure 3.5 demonstrates an example calibration for sensor 101, and Table 3.4 lists all of the sensors and their calibration equations. Note that in the equations shown in Table 3.4, the variable x represents the speed recorded by the sensor and the dependent variable y represents the actual speed of the passing vehicle.

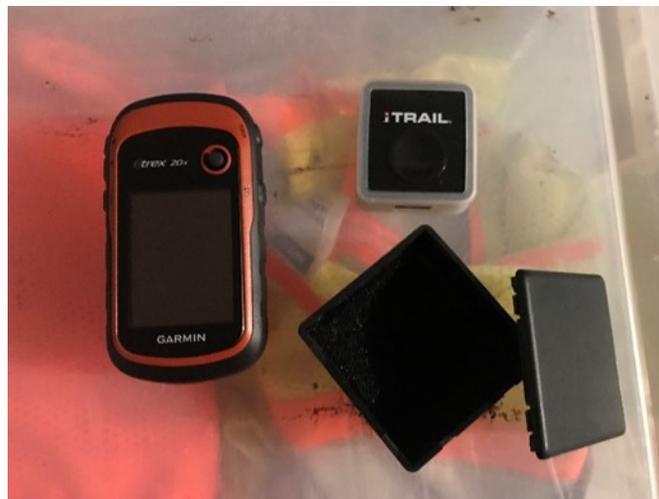
Figure 3.6: Handheld GPS device (left), and GPS tracker and casing for GPS tracker (right)

During each data collection period, two iTrail GPS trackers Figure 3.6 were placed on the light bar of the paver to record the trajectory of the paver during the nighttime paving operation. The GPS data was instrumental in determining the proximity of the paver to the traffic sensor locations where driver speed selection was being collected. GPS Trackers were placed on the paver before each data collection period while it was parked in the yard, and then removed after the data collection period to download the data for analysis. Figure 3.6 also shows a hand-held GPS device used in the data collection process. This device was used to record the longitude and latitude of the traffic sensors placed on the road. These values were later used during the analysis after the study period to provide a location of the sensors on each day. However, a 5 to 10 ft. deviation in accuracy was reported in several records. The researchers corrected the location using Google maps after sensor placement on each day.

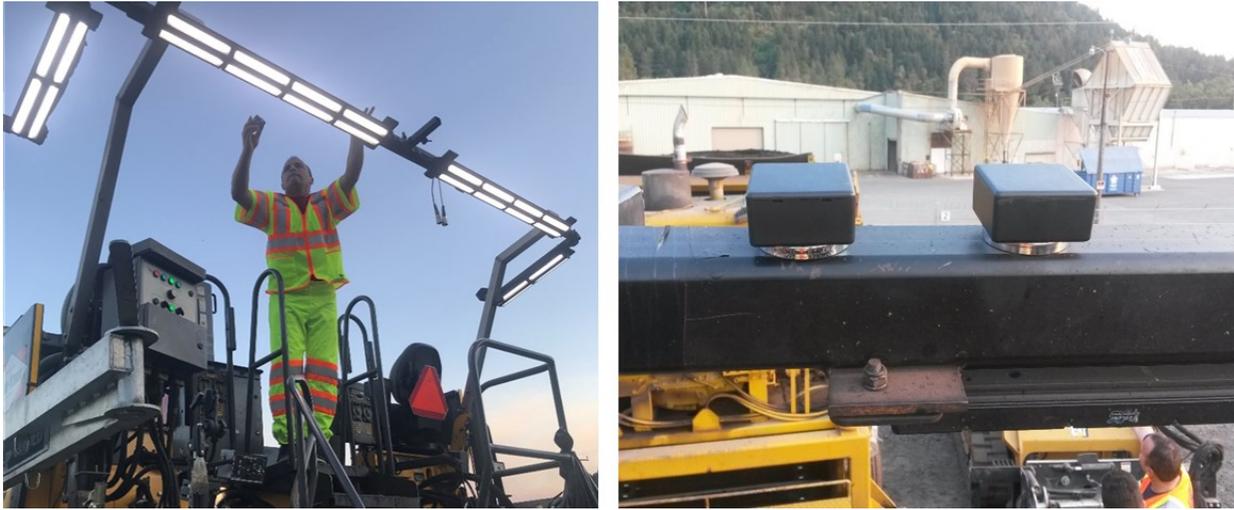
Figure 3.7: GPS sensor installation (left), and location on the paver light bar (right)

Figure 3.7 shows the GPS sensor placement on the paver. The 1.5”x1.5” devices were protected using a casing with magnetic attachment that attached to the metal light bar on the paver. Attachment to the light bar ensured that the sensors would not interfere with or get damaged from the paver operations, and that there would be a continuous clear signal to the tracking

satellites. After retrieving the GPS trackers from the paver, time stamped GPS data (longitude and latitude) was downloaded using the iTrail software in .csv format for analysis.

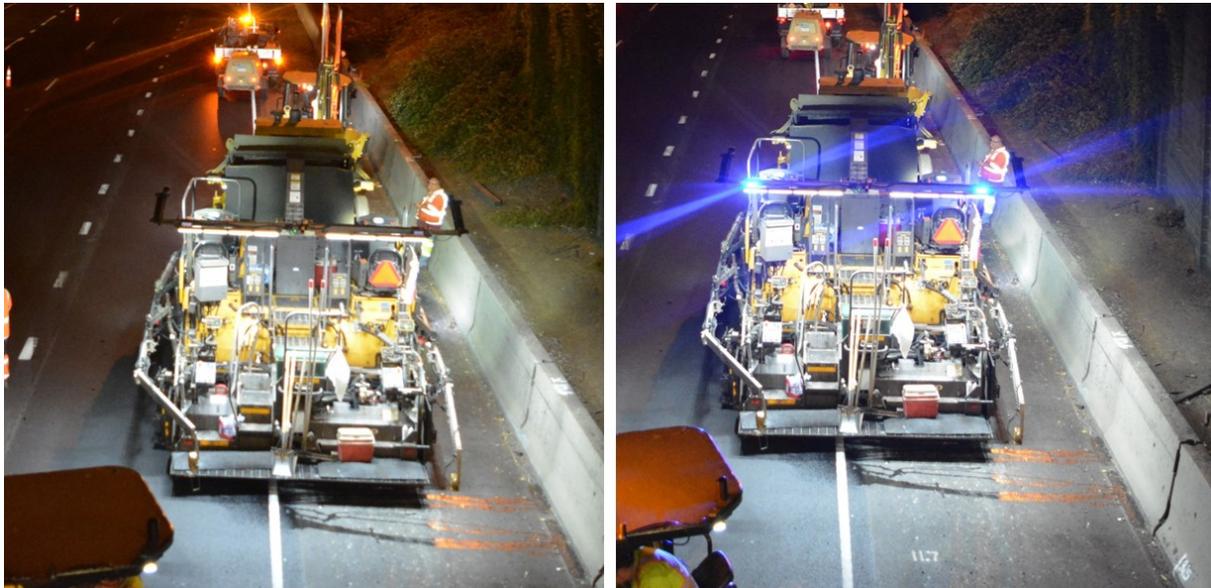
Figure 4.1: Paver with flashing blue lights off (left) and blue lights on (right)

As previously described, traffic sensors were placed on the road surface and GPS trackers were placed on the paver. The control treatment was the flashing blue lights on the paver turned off and the alternate treatment was the flashing blue lights turned on (see Figure 4.1). The blue lights were flashing; the left photo in Figure 4.1 shows the blue lights when they were off, and the right photo shows the blue lights on. Both of the individual blue lights on the paver flash simultaneously, i.e., both on at the same time and both off at the same time. A close-up view of one of the blue lights installed on the light bar of the paving equipment is displayed in Figure 4.2.

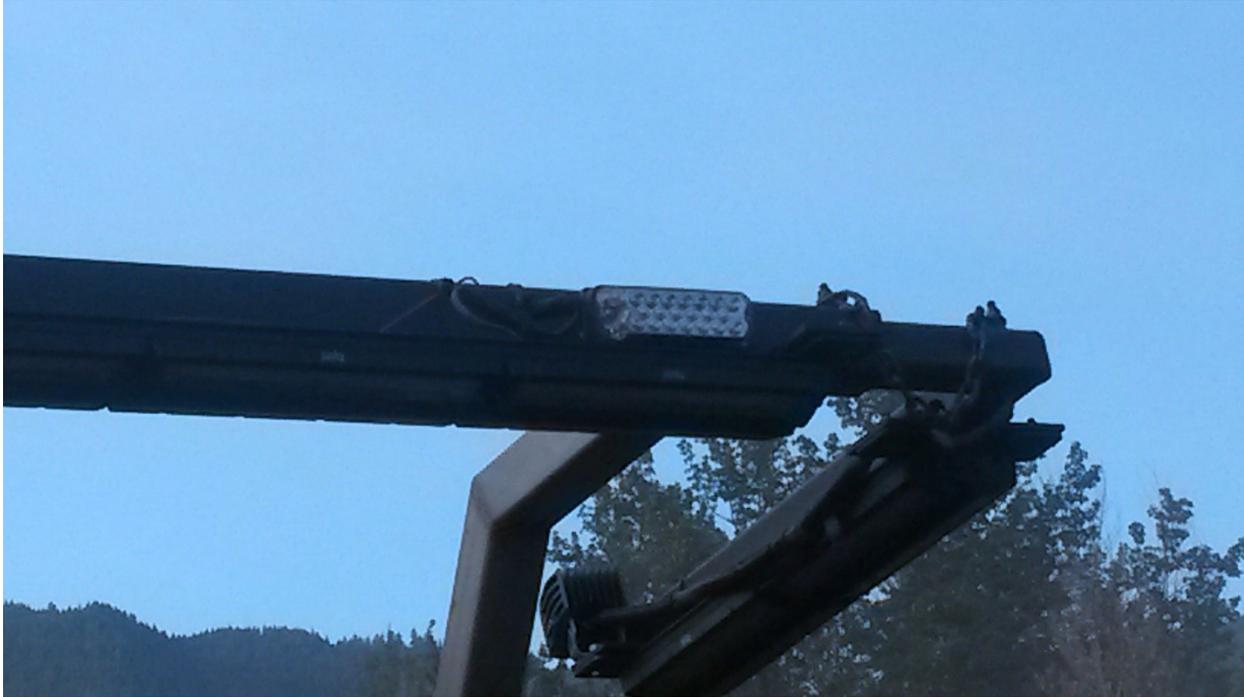
Figure 4.2: Blue light installed on paving equipment

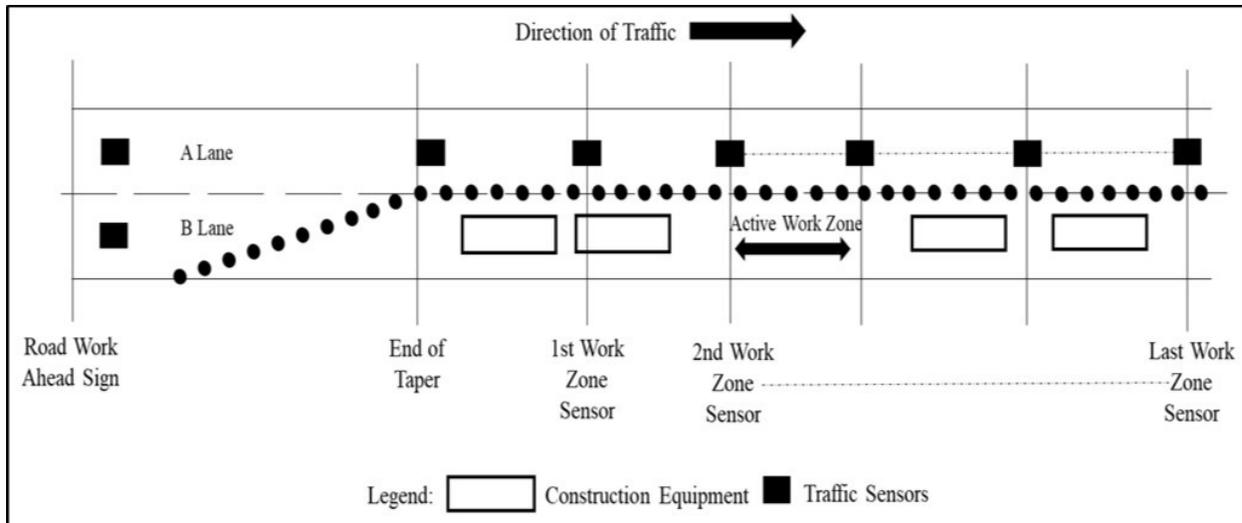
Figure 4.3: Typical sensor placement plan in work zone

Contrary to Figure 4.3, sensors were not placed exactly along the centerline of a lane; rather they were shifted slightly off-center of the travel lane, farther away from the work zone. Placing the sensors in this manner was designed to take into account the driving behavior through a work zone where drivers tend to position their driving path slightly away from the line of cones (Gambatese & Jafarnejad, 2017).

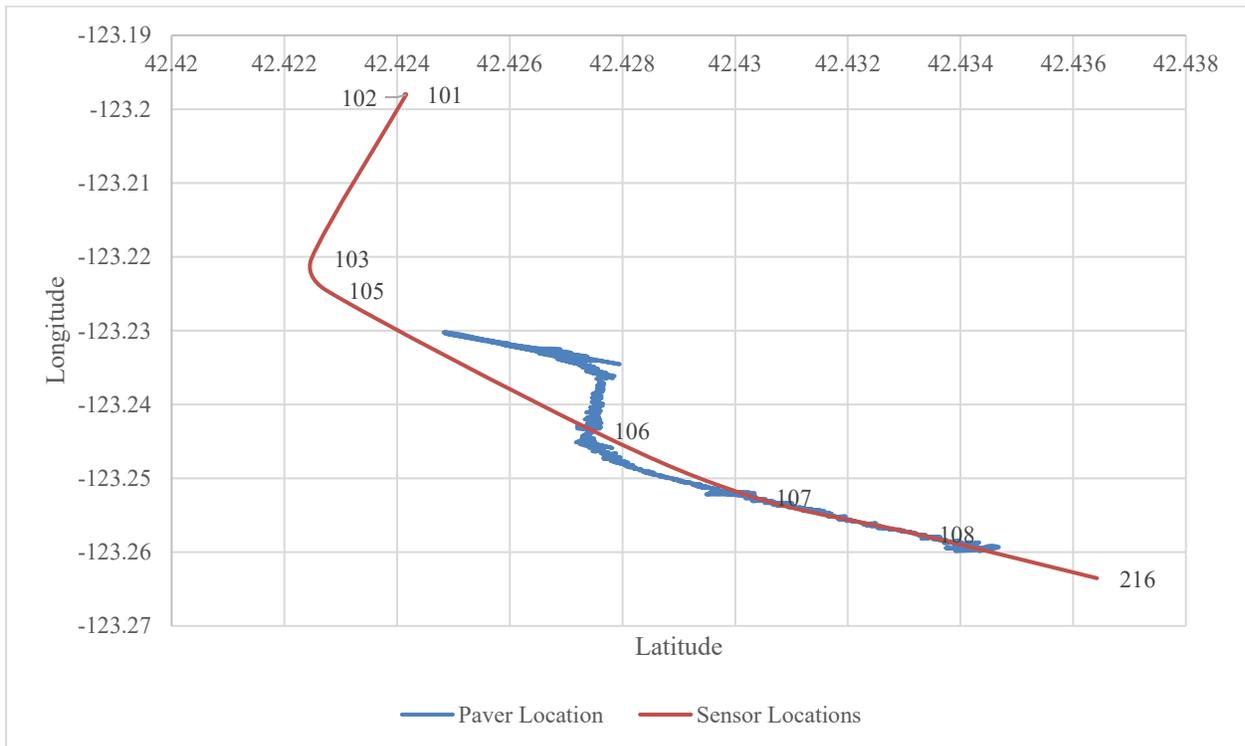
Figure 4.6: Sensor and paver locations

To isolate the influence of the driver behavior with the blue lights on, the position of the paver in relation to the traffic sensor needed to be identified. The GPS tracker attached to the paver allowed for the re-creation of the paver's travel path. The paver's travel path could then be overlaid with the location of the traffic sensors. An example of the relationship between the paver location and the sensor locations is shown in Figure 4.6.

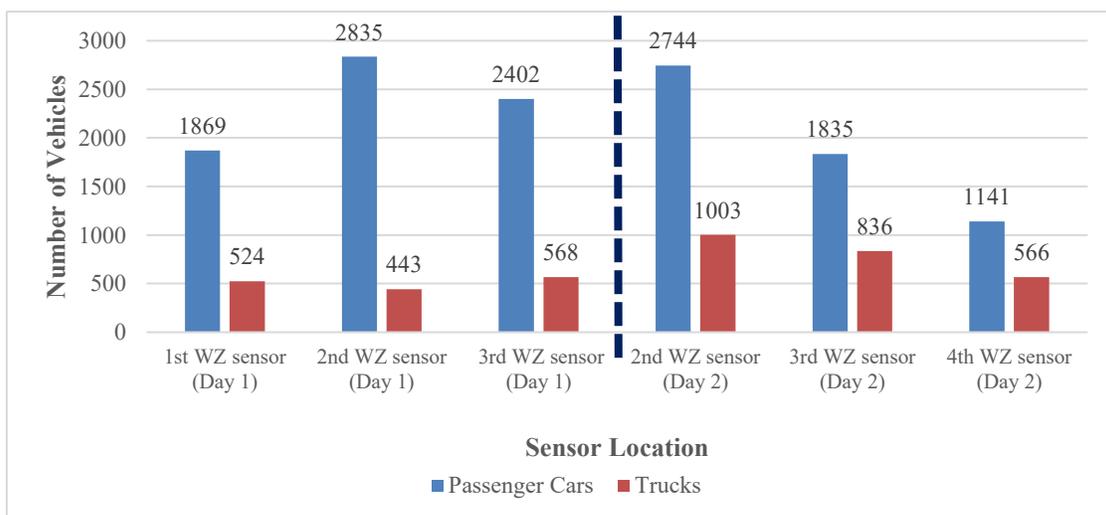
Figure 5.1: Traffic volumes for different vehicle types recorded by active WZ sensors for day 1 (blue lights on) and day 2 (blue lights off) (Case Study 1)

In this case study, data was collected from 23:00 until 04:00 the next morning on each night of testing. Figure 5.1 shows the number of vehicles passing through the work zone at different locations in Case Study 1 for the first day of testing when the blue lights were on and the second day when the blue lights were off. The data were recorded by different sensors in the middle of the work zone. There is some difference in the number of passing vehicles on these days. In general, it can be seen that Day 1 (blue lights on) had a greater number of passenger cars (vehicles < 25 feet in length) and Day 2 (blue lights off) had a greater number of trucks (vehicles > 25 feet in length). There are a number of reasons why the volumes may differ from one sensor to another on the same day of data collection. Perhaps the traffic sensor produced a faulty data point and an error code was generated (as described above). The difference in number of vehicles may also occur when construction vehicles (e.g., asphalt trucks) enter the active work area and do not travel across some sensors. Also, if there is an entrance/exit in the middle of the active work area, some vehicles may enter/exit the roadway and not travel over all sensors.

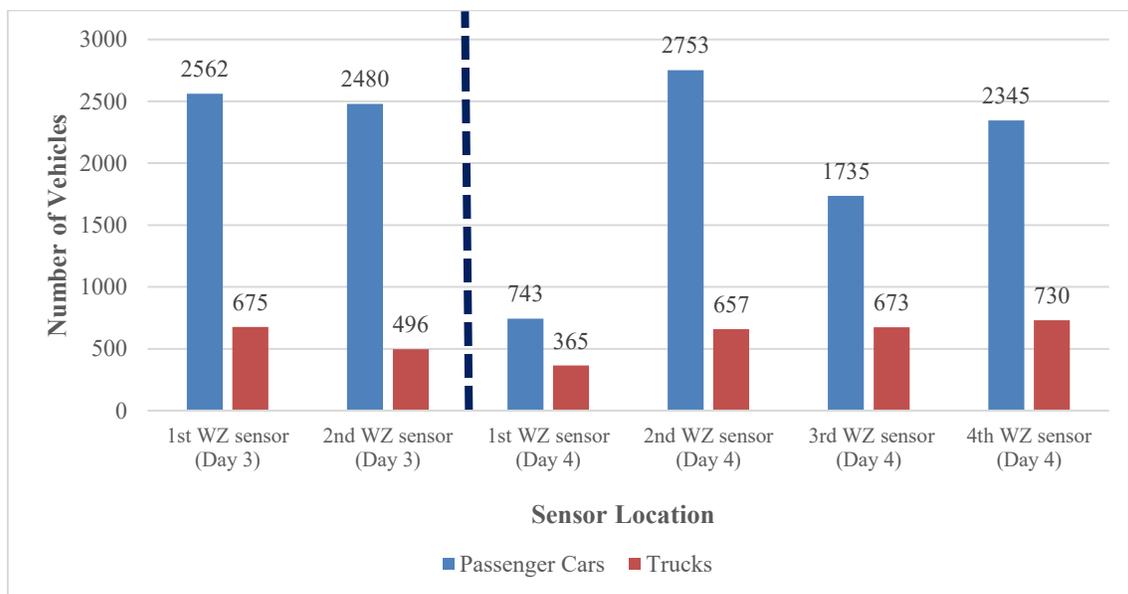
Figure 5.2: Traffic volumes for different vehicle types recorded by active WZ sensors for day 3 (blue lights off) and day 4 (blue lights on) (Case Study 1)

Figure 5.2 shows how the number of passenger cars and the number of trucks changed in the work zone over the course of each night of testing for Day 3 and Day 4. On Day 3 of testing, the blue lights were off and on Day 4 the blue lights were on. The data was collected from 23:00 to 04:00. There is variation in the volumes recorded by the different sensors. On Day 4, the lowest number of passenger cars was 743 as recorded by the 1st work zone sensor, and the highest number of passenger cars was 2,753 as recorded by the 2nd work zone sensor. As seen in the same figure, the lowest number of trucks was 365 as recorded by the 1st work zone sensor, and the highest number of trucks was 730 as record by the 4th work zone sensor. Compared with Day 3, the greatest and the least numbers of passenger cars and trucks were recorded by different sensors on Day 4. The variation in volumes between sensors on the same day may be due to several reasons as mentioned in the previous paragraph. The work zone placement plan followed the same layout for each night’s work: roadwork ahead sign, progressive end of taper with lane drop, and single lane through the active work area. The number of sensors placed on the roadway was determined based on the planned length of paving for a particular night. Paver location throughout the work zone during the data collection period further dictated the sensors relevant to the study by being impacted by the location of paver. As real-time paving operations periodically encompass slight changes in plans, a wider safety net (additional sensors) was cast and as a result, for all recorded days, no data was missed.

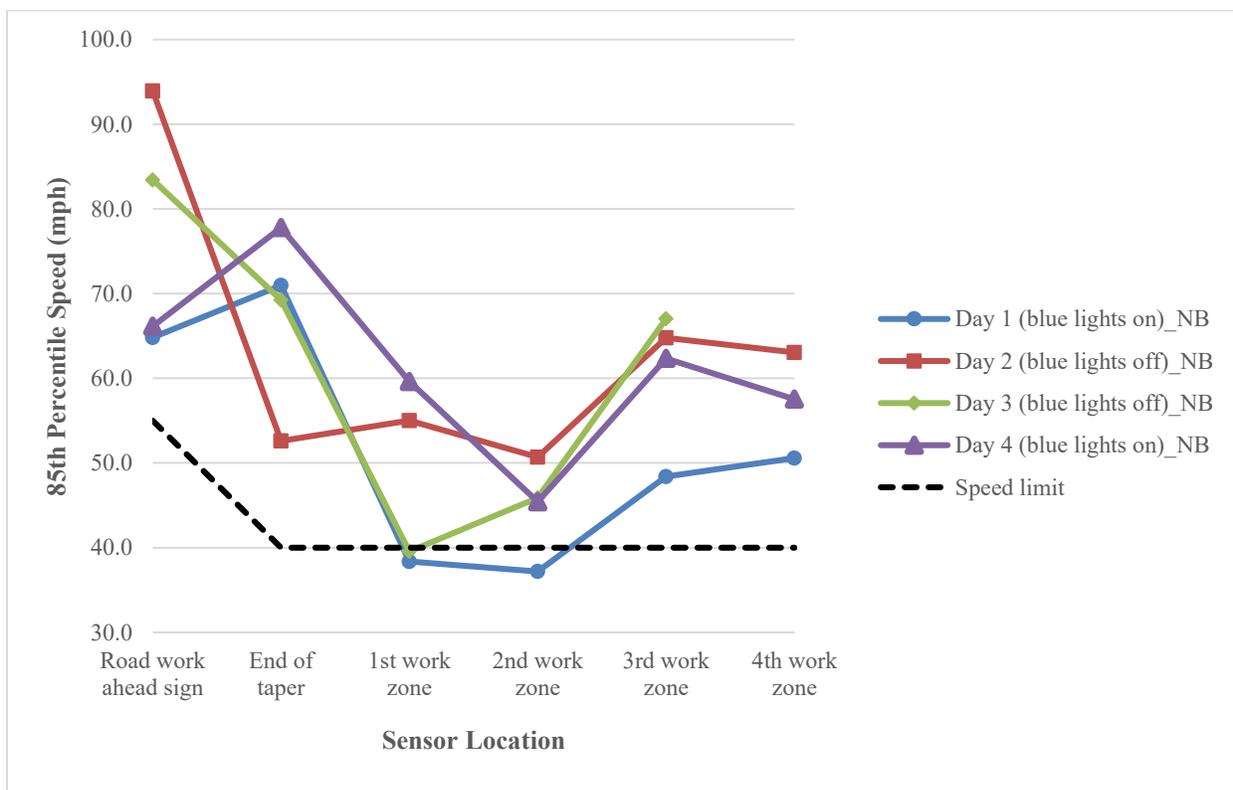
Figure 5.3: Vehicle speed (85th percentile) at different locations for all days on I-5 Hassalo (Case Study 1)

on Days 1 and 4. As seen in the figure, vehicle speed changes from one location to another. The lowest 85th percentile speed of the passing vehicles was 37.2 mph as recorded by the 2nd work zone sensor on Day 1 (blue lights on), and the highest 85th percentile speed of the passing vehicles was 93.9 mph recorded by the A-lane sensor at the RWA sign. The largest change in speed between the end of taper and within the active work area, approximately 32 mph, occurred on Day 4. The reduction in speed is greatest at the 2nd work zone sensor, after which the speed increases gradually. In general, vehicle speed in the active work zone area is higher than the temporary speed limit (40 mph) except at the 1st and 2nd work zone locations. It should be remembered that the construction equipment moves down the roadway. As a result, and given that previous research shows that vehicle speeds typically are lower adjacent the large equipment (e.g., paver and grinder), the 85th percentile speeds at the 1st work zone sensor are impacted by the equipment at a different time than the speeds at the downstream sensors. Vehicle speed at different times during the work period are discussed below.

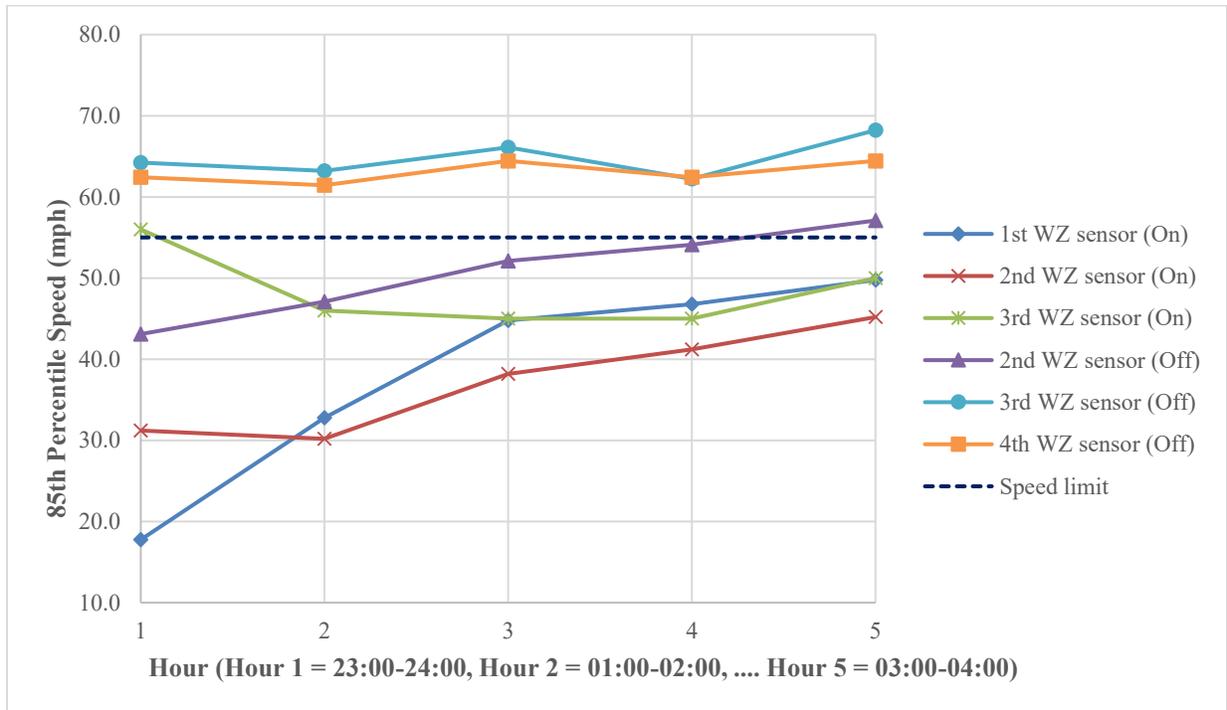
Figure 5.4: Hourly vehicle speed (85% percentile) at active WZ sensors for day 1 (blue lights on) and day 2 (blue lights off) (Case Study 1)

It should be noted that the 1st WZ sensor on this case study was typically located at or near the start of paving for the night. At this location, the construction equipment is typically staged in preparation for the paving at the beginning of the work shift. The paver often remains at this location for a longer period of time while the workers and equipment are mobilized to the site, the grinder progresses downstream, and the paving joint is prepared. Therefore, given that vehicle speeds are typically lower adjacent equipment and the traffic volumes are greater earlier in the work shift, the speeds at this location were found to typically be lower than at other locations and at later times during the paving operation.

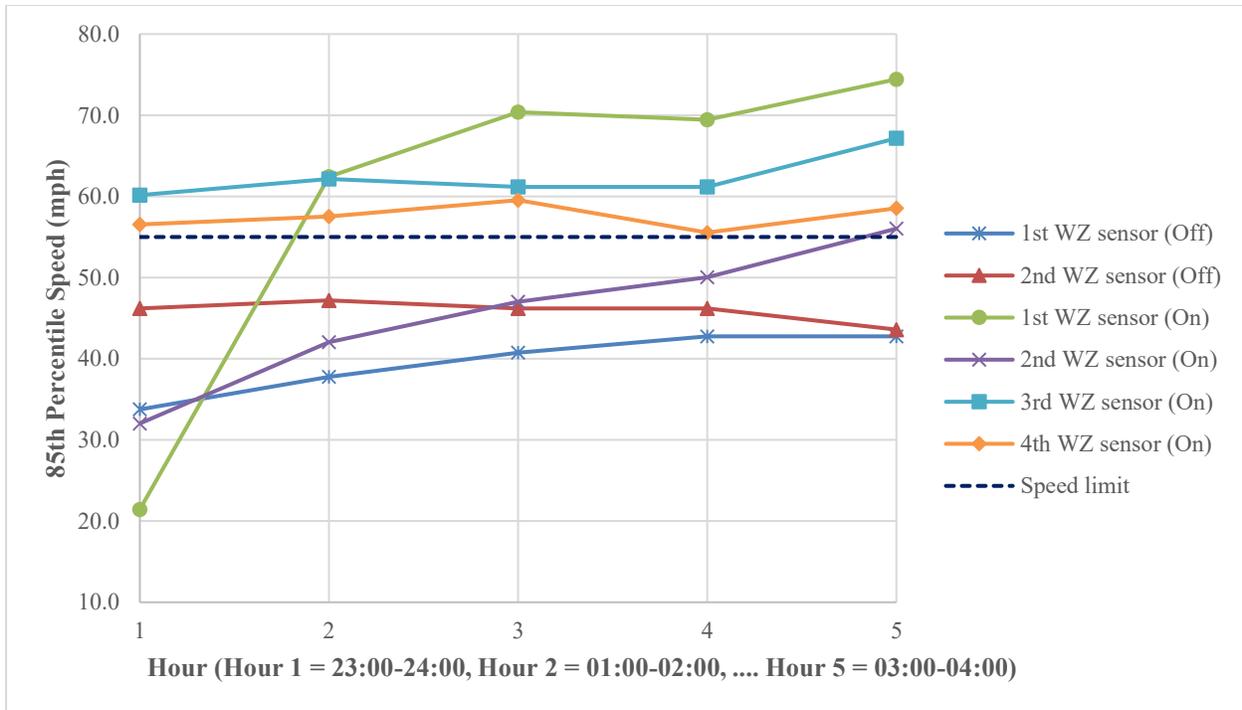
Figure 5.5: Hourly vehicle speed (85% percentile) at active WZ sensors for day 3 (blue lights off) and day 4 (blue lights on) (Case Study #1)

Similarly, Figure 5.5 explains the change in 85th percentile speed for the vehicles during five hours of data collection on Days 3 and 4. As with all of the case studies, the distance between the 1st WZ sensor in the active work area and the end of the taper was approximately the same on all data collection days (0.3 - 0.4 miles). There were two active work zone sensors when the blue lights were off (Day 3) and four active work zone sensors when the blue lights were on (Day 4). The number of active work zone sensors from one day to the next may differ based on the length of paving which the contractor completed on each day (e.g., a fewer number of sensors when the length of paving was shorter). An imbalance in the number of active work zone sensors may contribute to the difference in speeds for these two days where some sensors did not show a reduction in speed when the blue lights were on. Lastly, as described above for Figure 5.4, the speeds at the 1st WZ sensor were typically found to be lower than at other sensors, perhaps due to the staging of the equipment, length of time the equipment stays at this location, and the volume of traffic when the equipment is at this location.

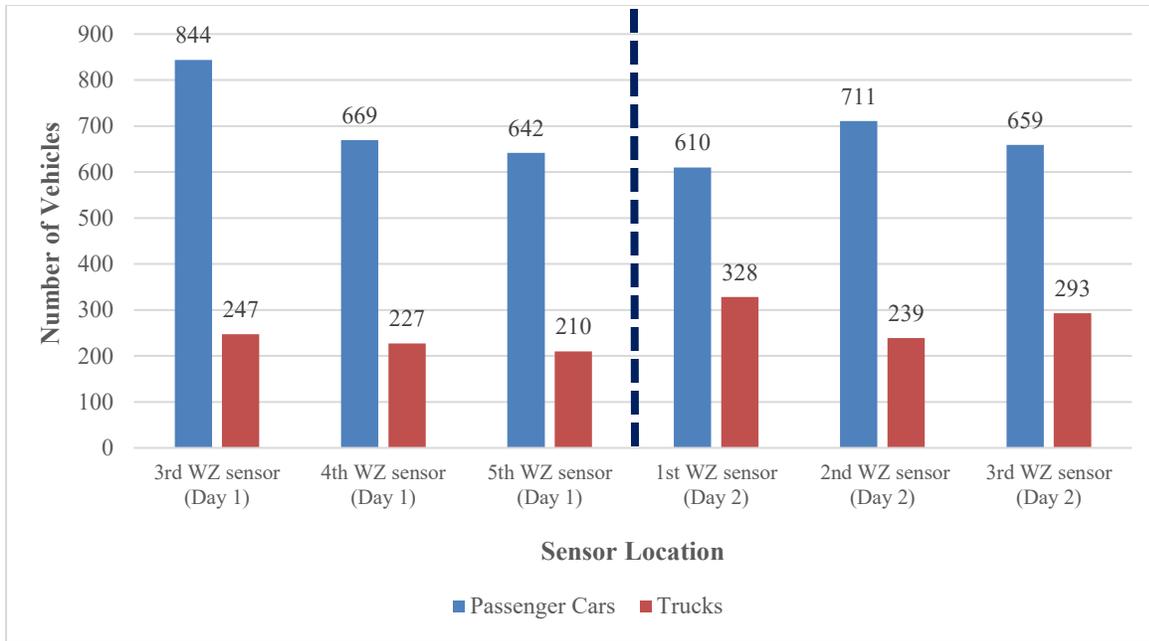
Figure 5.6: Traffic volumes for different vehicle types recorded by active WZ sensors for day 1 (blue lights off) and day 2 (blue lights on) (Case Study 2)

In this case study, data was collected from 22:00 until 04:00 the next morning on each night of testing. Figure 5.6 shows the number of vehicles passing through the work zone at different locations in Case Study 2 for two days of testing when the blue lights were on and then off. The sensors were placed in the southbound lanes on Day 1 and in the northbound lanes on Day 2. The data were recorded by different active sensors in the middle of the active work area. There were three active sensors when the blue lights were off (Day 1) and three active sensors when the blue lights were on (Day 2). There is some difference in the number of passing vehicles on these days. In general, it can be seen that Day 1 (blue lights off) had the greatest number of passenger cars (844 vehicles) and Day 2 (blue lights on) had the greatest number of trucks (328 vehicles). However, based on the work zone layout, multiple entry and exit ramps were superimposed in the plan to account for variability in consecutive volumes. In addition, the accuracy of the sensor readings, and subsequent filtering of the data to account for inaccurate/error readings, had an impact on the differences in recorded traffic volumes.

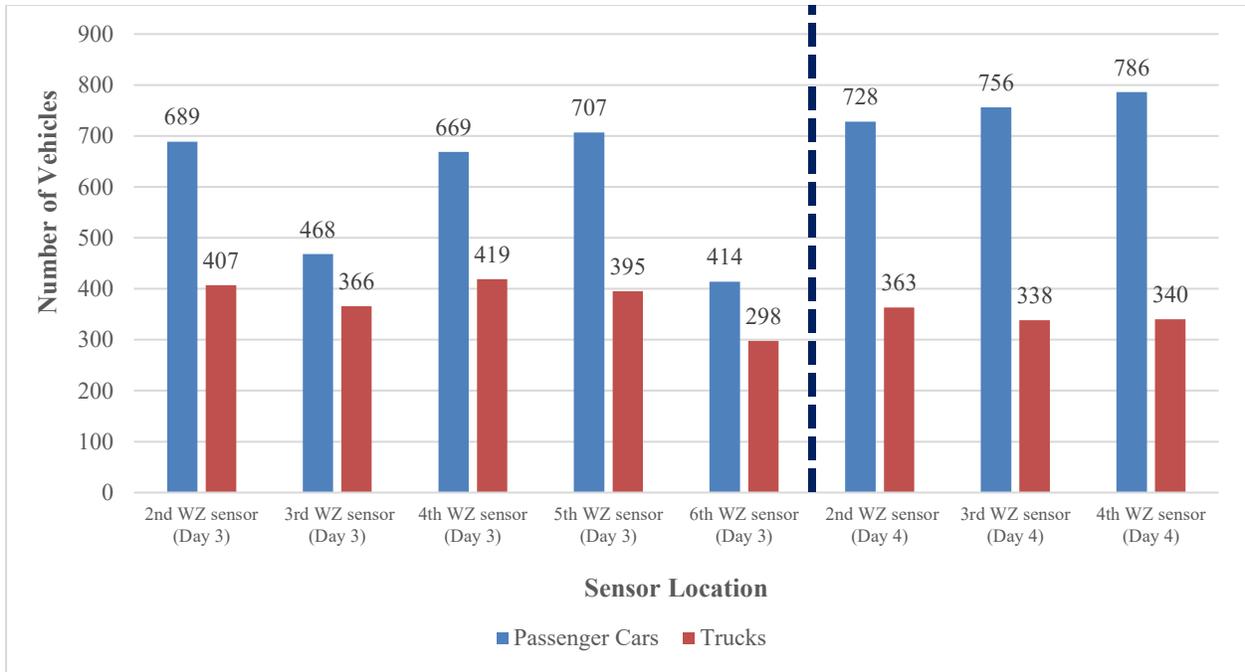
Figure 5.7: Traffic volumes for different vehicle types recorded by active WZ sensors for day 3 (blue lights off) and day 4 (blue lights on) (Case Study 2)

Similarly, Figure 5.7 shows how the number of passenger cars and trucks changed in the work zone over the course of each night of testing for Day 3 and Day 4. The blue lights on Day 3 of testing were off and on Day 4 the blue lights were on. The sensors were placed in the northbound lanes on both days. The data collection took place between 22:00 and 04:00 the next morning (six hours of data collection). There is variation in the volumes recorded by the different sensors. The lowest number of passenger cars was 414 as recorded by the 6th work zone sensor on Day 3 (blue lights off), and the highest number of passenger cars was 786 as record by the 4th work zone sensor on Day 4 (blue lights on). As seen in the same figure, the lowest number of trucks was 298 as recorded by the 6th work zone sensor on Day 3 (blue lights off), and the highest number of trucks was 419 as record by the 4th work zone sensor on Day 3. Day 3 had the greatest and lowest number of passenger cars and trucks, as recorded by the 6th work zone sensor in the work zone. As explained above, sensor accuracy and the number of entry and exit ramps have an impact on the total number of vehicles recorded by the sensors and used in the data analysis.

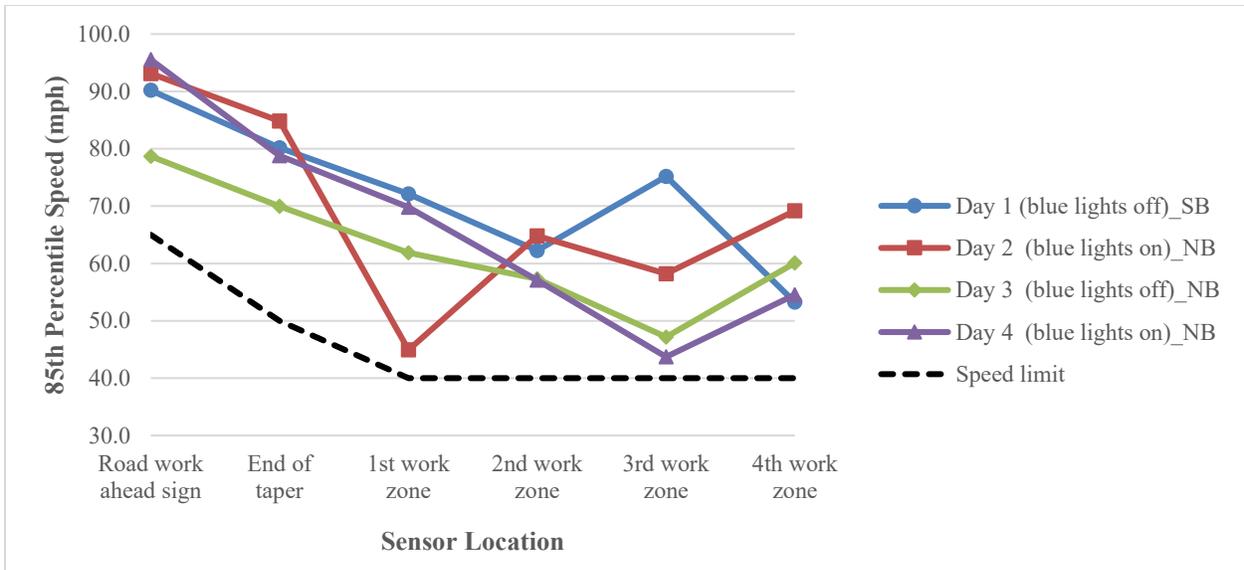
Figure 5.8: Vehicle speed (85th percentile) at different locations for all 4 days (Case Study 2)

As shown in Figure 5.8, there is variation in the 85th percentile vehicle speed for vehicles recorded at different locations in this case study. The figure shows the 85th percentile speed of the vehicles recorded at different locations including at the RWA sign, end of taper, and all of the sensors in the work zone from 22:00 through 04:00 on the four days of testing. The speed limit was 65 mph at the RWA sign and the temporarily reduced speed limit in the work zone was 40 mph. For Day 1, the sensors were placed in the southbound lanes, while on the other days the sensors were located in the northbound lanes. As can be seen in the figure, there is a change in speed from one location to another in the northbound lanes on Days 2 and 3. The lowest 85th percentile speed of the passing vehicles was 44.9 mph as recorded by the 1st work zone sensor when the blue lights were on (Day 4), and the highest 85th percentile speed of the passing vehicles was 93.1 mph for the same day as recorded by the A-lane sensor at the RWA sign. There is a reduction in the 85th percentile speed at different locations in the work zone. The speed increased gradually for Day 2 and Day 3 after the 3rd work zone sensor. In general, the 85th percentile speed of the vehicles in the work zone was higher than the work zone speed limit (40 mph).

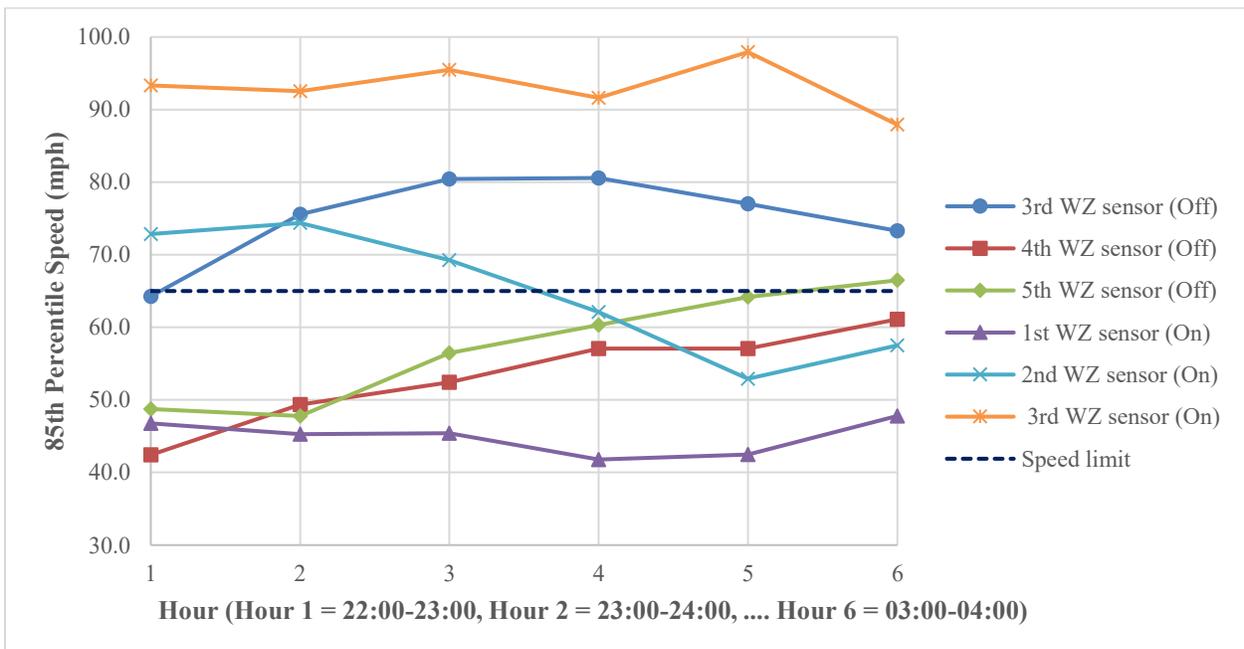
Figure 5.9: Hourly vehicle speed (85% percentile) at active WZ sensors for day 1 (blue lights off) and day 2 (blue lights on) (Case Study 2)

Figure 5.9 shows the change in the 85th percentile vehicle speed over the course of the work shift for Day 1 when the blue lights were off and for Day 2 when the blue lights were on. There were three active WZ sensors on each day. With regard to Day 2 (blue lights on), the 1st work zone sensor shows a clear reduction in speed in the work zone. Generally, the 85th percentile speed in the work zone when the blue lights were off (Day 1) was higher than the 85th percentile speed when the blue lights were on (Day 2), except for the 3rd work zone sensor (blue lights on).

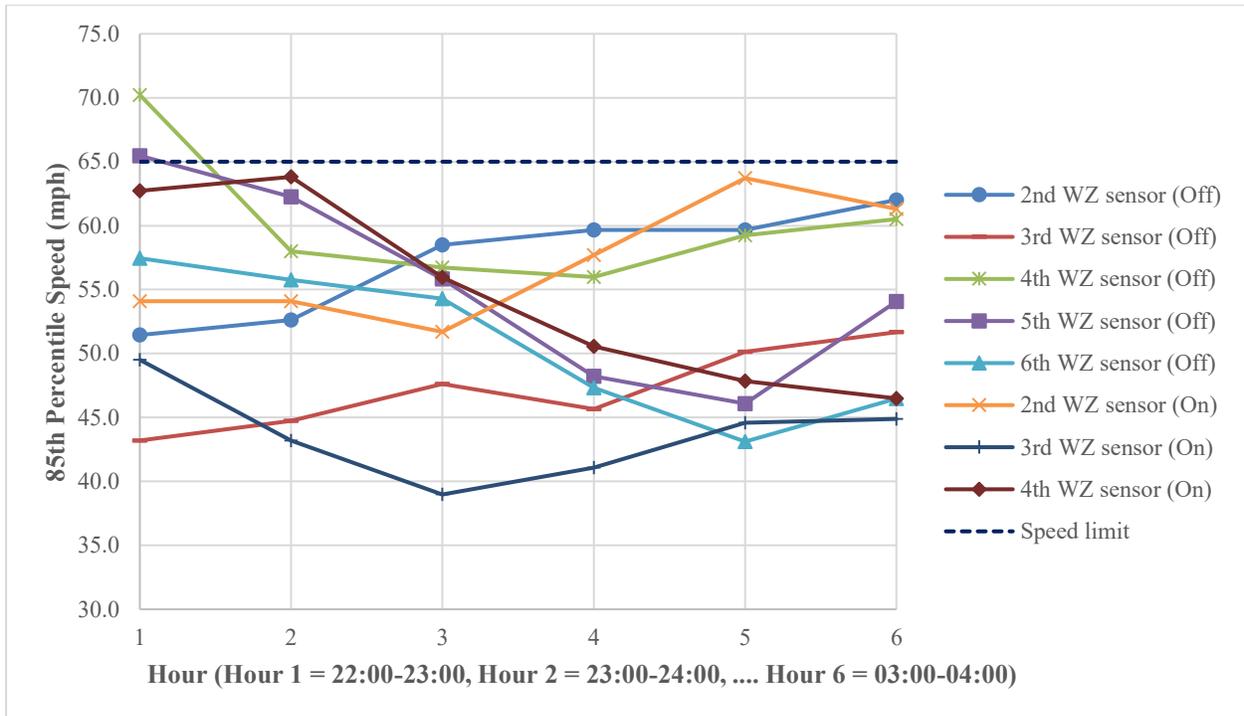
Figure 5.10: Hourly vehicle speed (85% percentile) at active WZ sensors for day 3 (blue lights off) and day 4 (blue lights on) (Case Study 2)

As shown in Figure 5.10, there were three active WZ sensors when the blue lights were off (Day 3) and five sensors when the blue lights were on (Day 4). Based on visual inspection of the figure, the variation in the 85th percentile vehicle speed does not follow a specific trend; some sensors show a reduction in speed later in the work shift when the blue light was on and other sensors did not show any reduction.

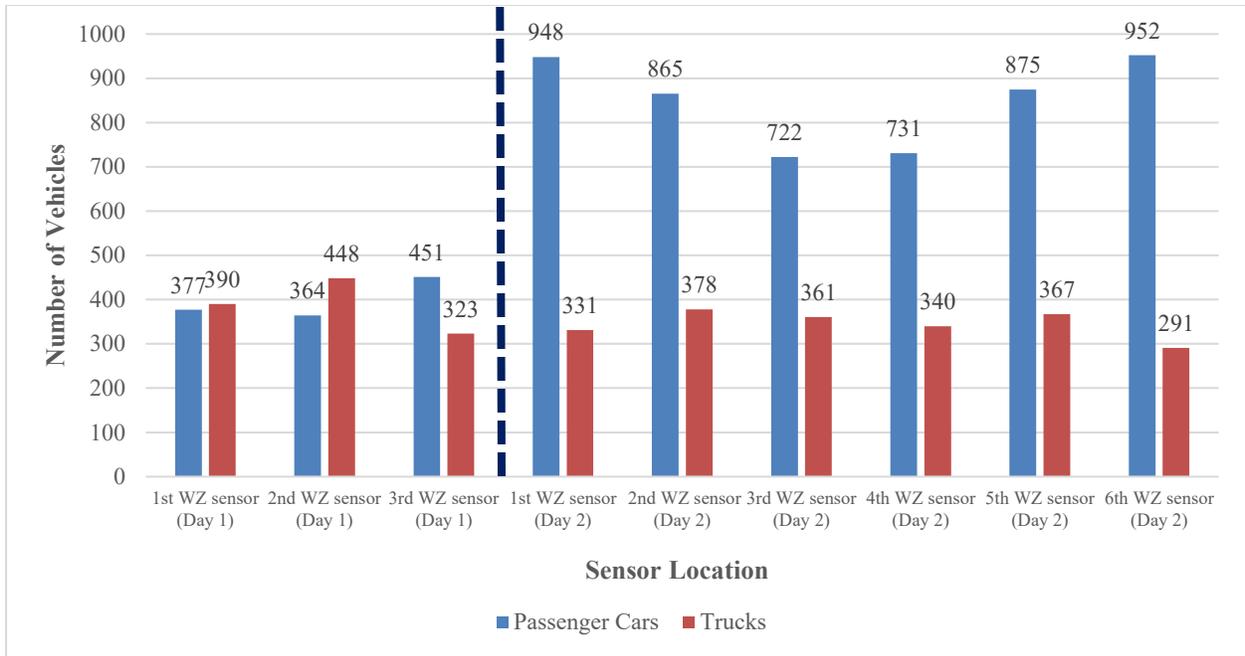
Figure 5.11: Traffic volumes for different vehicle types recorded by active WZ sensors for day1 (blue lights off) and day 2 (blue lights on) (Case Study 3)

Similar to Case Study 2, data was collected from 22:00 until 04:00 the next morning on each night of testing for Case Study 3. Figure 5.11 presents the number of vehicles passing through the work zone during Case Study 3 for two days of testing when the blue lights were off (Day 1) and when the blue lights were on (Day 2). The data were recorded by different active sensors in the middle of the work zone. There were three active sensors on Day 1 when the blue lights were off and six active sensors on Day 2 when the blue lights were on. There is a difference in the number of passing vehicles on these two days. It can be noticed that Day 2 (blue lights on) had the greatest number of passenger cars (952 vehicles) as recorded by the 6th work zone sensor. Also, Day 1 (blue lights off) had the greatest number of trucks (448 vehicles) as recorded by the 2nd work zone sensor.

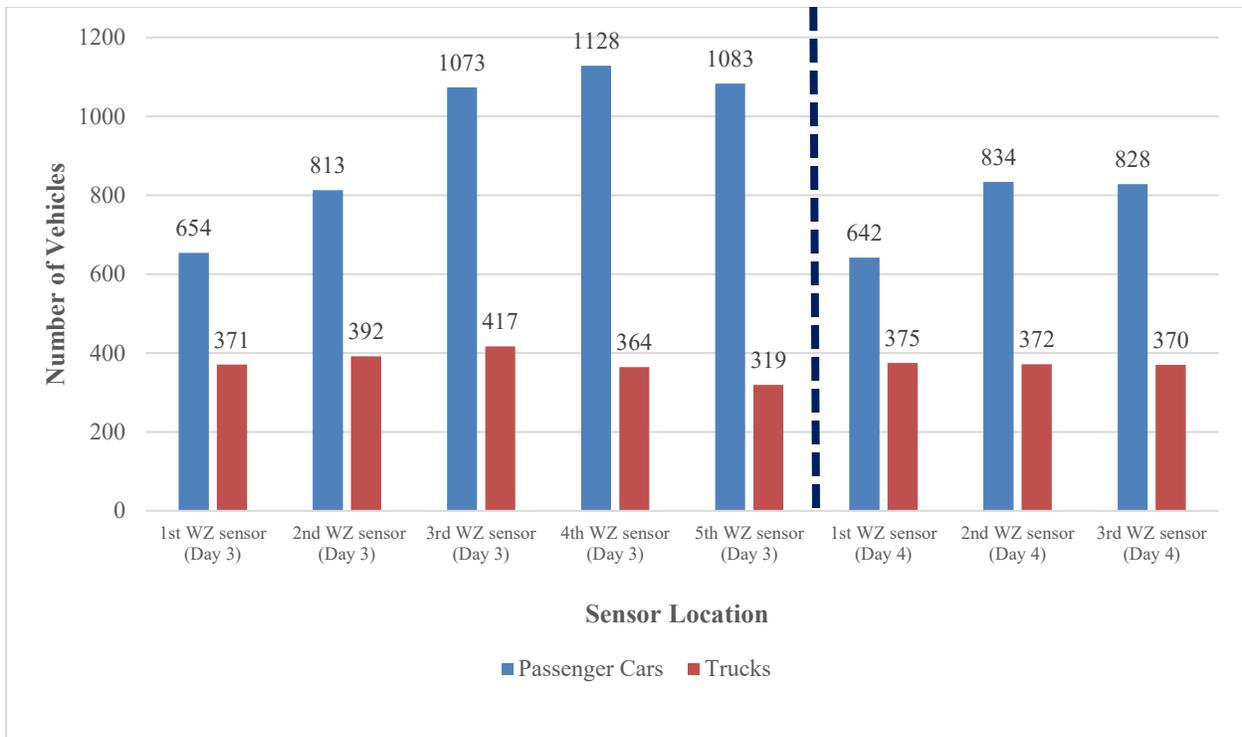
Figure 5.12: Traffic volumes for different vehicle types recorded by active WZ sensors for day 3 (blue lights off) and day 4 (blue lights on) (Case Study 3)

Figure 5.12 shows how the number of passing vehicles changed in the work zone over the course of Days 3 and 4 of testing. The blue lights on Day 3 were off and on Day 4 the blue lights were on. Data collection took place between 22:00 and 04:00, a period of 6 hours. Generally, there was variation in the volume between the different sensors. The fewest number of passenger cars was 642 as recorded by the 1st sensor in the work zone on Day 4 (blue lights on), and the greatest number of passenger cars was 1,128 as record by the 4th work zone sensor on Day 3 (blue lights off). As seen in the same figure, the fewest number of trucks was 319 as recorded by the 5th work zone sensor on Day 4, and the greatest number of trucks was 417 as record by the 3rd work zone sensor on Day 3. The greatest and fewest number of passenger cars and trucks occurred on Day 3, as recorded by different sensors.
