**USE OF BLUE LIGHTS ON PAVING
EQUIPMENT IN WORK ZONES**

Final Report

ODOT ORDER NO. 19-03

Oregon Department of Transportation

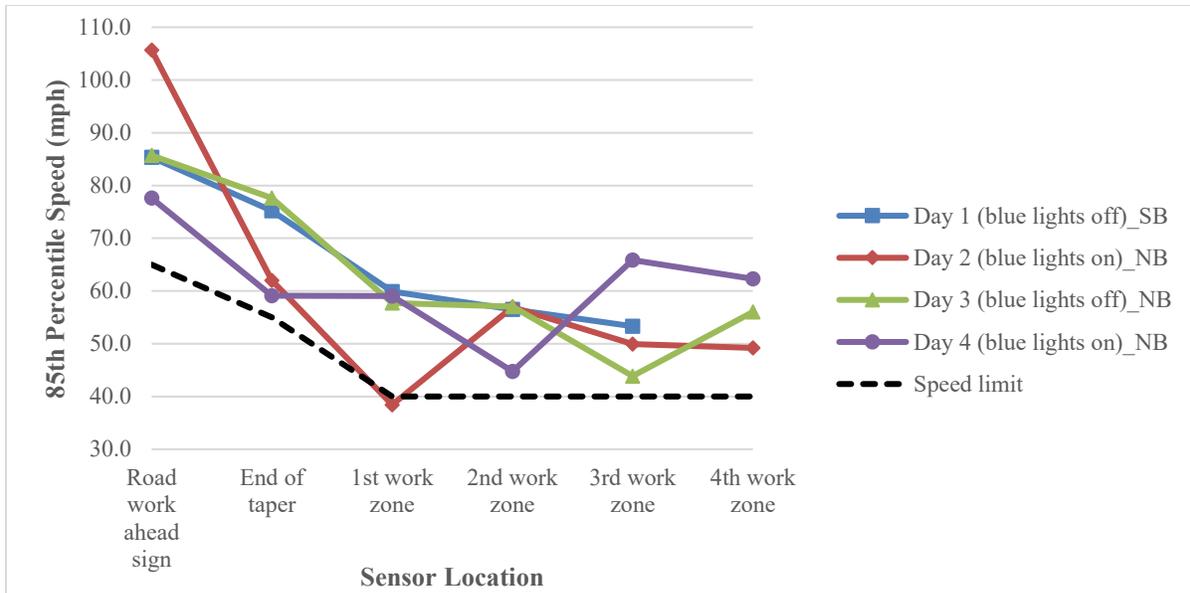
Figure 5.13: Vehicle speed (85th percentile) at different locations for all four days (Case Study 3)

The 85th percentile vehicle speed for different locations in the work zone on different days is shown in Figure 5.13. The figure shows the 85th percentile speed of the vehicles recorded at the RWA sign, end of taper, and all of the sensor locations in the work zone from 22:00 to 04:00 on the four days of testing. The sensors were placed in the southbound lanes on Day 1 and in the northbound lanes on Days 2, 3, and 4. The speed limit was 65 mph at the RWA sign and the temporarily reduced speed limit in the work zone was 40 mph. As seen in the figure, there is variation in the speed between the different locations in the northbound lanes on Days 2 and 3. The lowest 85th percentile speed of the passing vehicles was 38.4 mph as recorded by the 1st work zone sensor, and the highest 85th percentile speed of the passing vehicles was 105.7 mph recorded by the A-lane sensor at the RWA sign. The reduction in speed is clear at the 1st work zone sensor when the blue lights were on (Day 2). After the 3rd work zone sensor, the speed increases gradually on all days. In general, the 85th percentile speed in the work zone is higher than the temporary speed limit (40 mph) except at the 1st work zone sensor location for Day 2.

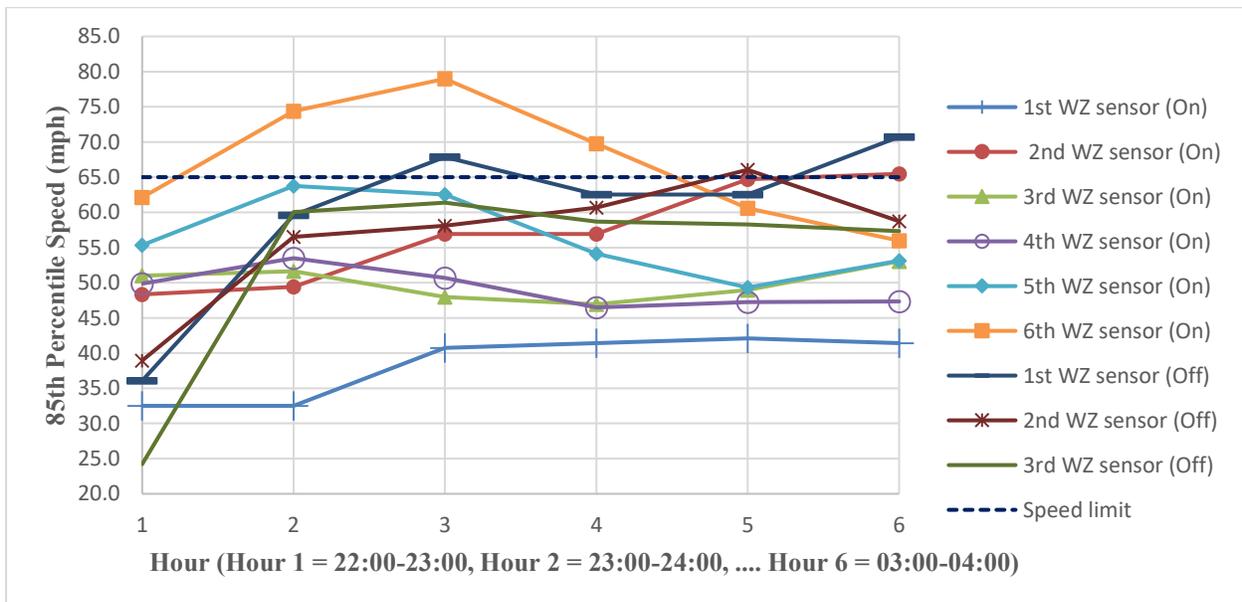
Figure 5.14: Hourly vehicle speed (85% percentile) at active WZ sensors for day 1 (blue lights off) and day 2 (blue lights on) (Case Study 3)

For the third case study, the variation in the 85th percentile vehicle speed is clear in Figure 5.14. There were six active WZ sensors when the blue lights were turned on (Day 2), and three of the sensors (1st sensor, 3rd sensor, 4th sensor) show a reduction in speed in the work zone as compared with other sensors when the blue lights were off (Day 1). In general, there was variation in the 85th percentile speed on both days. It is also interesting to note that for those days when the blue lights were off, the 85th percentile speed was typically lower at the 1st WZ sensor location.

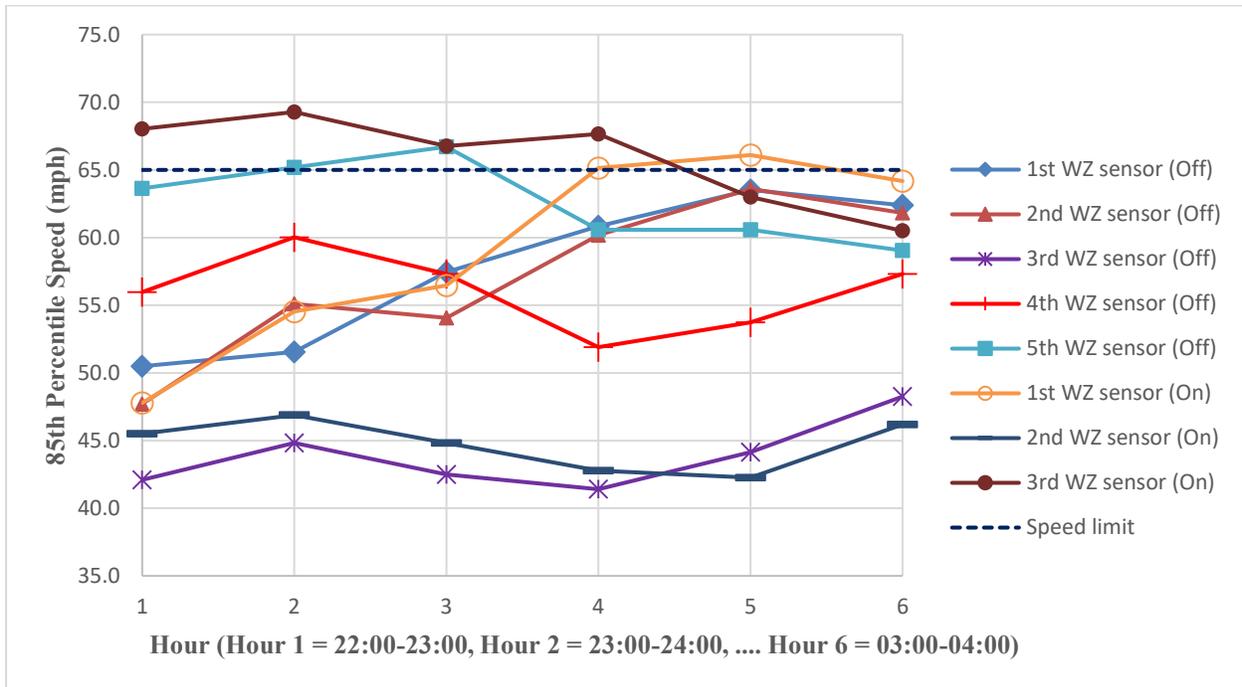
Figure 5.15: Hourly vehicle speed (85% percentile) at active WZ sensors for day 3 (blue lights off) and day 4 (blue lights on) (Case Study 3)

As seen in Figure 5.15, there were five active WZ sensors when the blue lights were off (Day 3) and three active WZ sensors when the blue lights were on (Day 4). The range of speed in the work zone for six hours of data collection was between 42.2 mph and 68 mph. Based on visual inspection of the figure, there is no specific pattern for the speed variation in the work zone where some sensors showed reduction in 85th percentile speed when the blue lights were on (Day 4) and other sensors did not show any reduction in speed. The 3rd WZ sensor with the blue lights off (Day 3) and the 2nd WZ sensor with the blue lights on (Day 4) consistently showed lower speeds than on all of the other days (both blue lights on and off). --

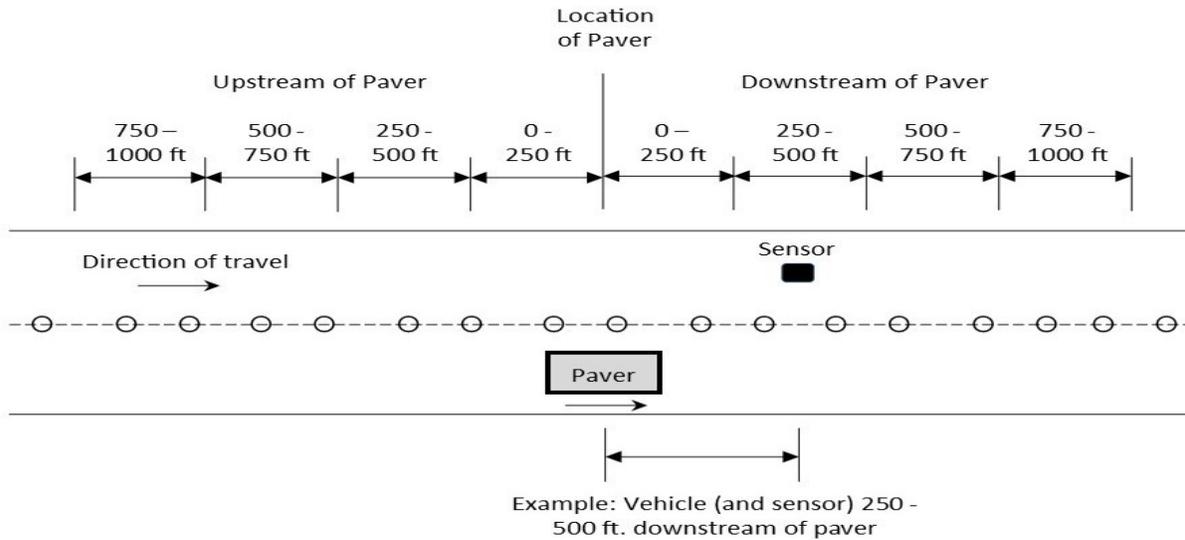
Figure 5.22: Data intervals for analysis – 250 ft. intervals dataset

However, for this screening of data to be meaningful, all of the sensors were, logically, not in proximity of the paving equipment during the entire data collection period. Using the location and time data from the GPS trackers placed on the paver, the recorded average speed of the paver was calculated to be 1.6 mph. Therefore, only one sensor with a radius of influence of 1,000 ft. was in the vicinity of the paver at one time. Two datasets were created that contained data at different intervals between 1,000 feet upstream and 1,000 feet downstream of the paver: one dataset based on 250 ft. intervals and the other based on 500 ft. intervals Figure 5.22 and Figure 5.23 illustrate the datasets for 250 ft. intervals and 500 ft. intervals, respectively. Each dataset was developed separately for all case studies, and included control data (blue lights off) and treatment data (blue lights on). Each dataset was then used for all further data analyses to determine the difference in speeds between the control days and the treatment days.

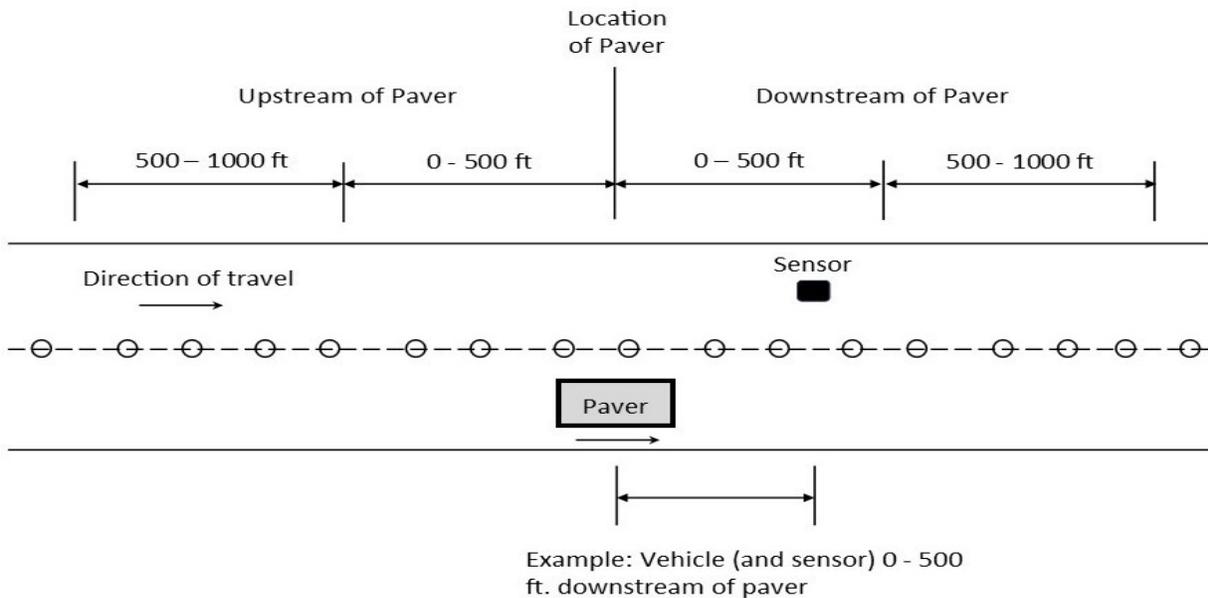
Figure 5.23: Data intervals for analysis – 500 ft. intervals dataset

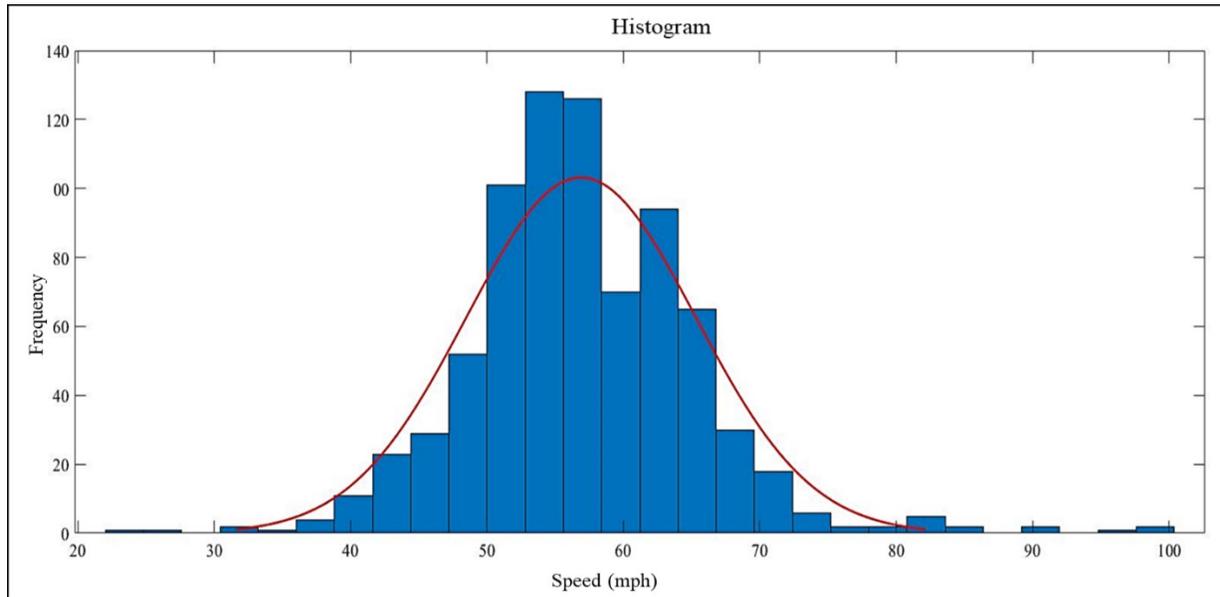
Figure 5.24: Histogram from sensor data at road work ahead sign (Case Study 1)

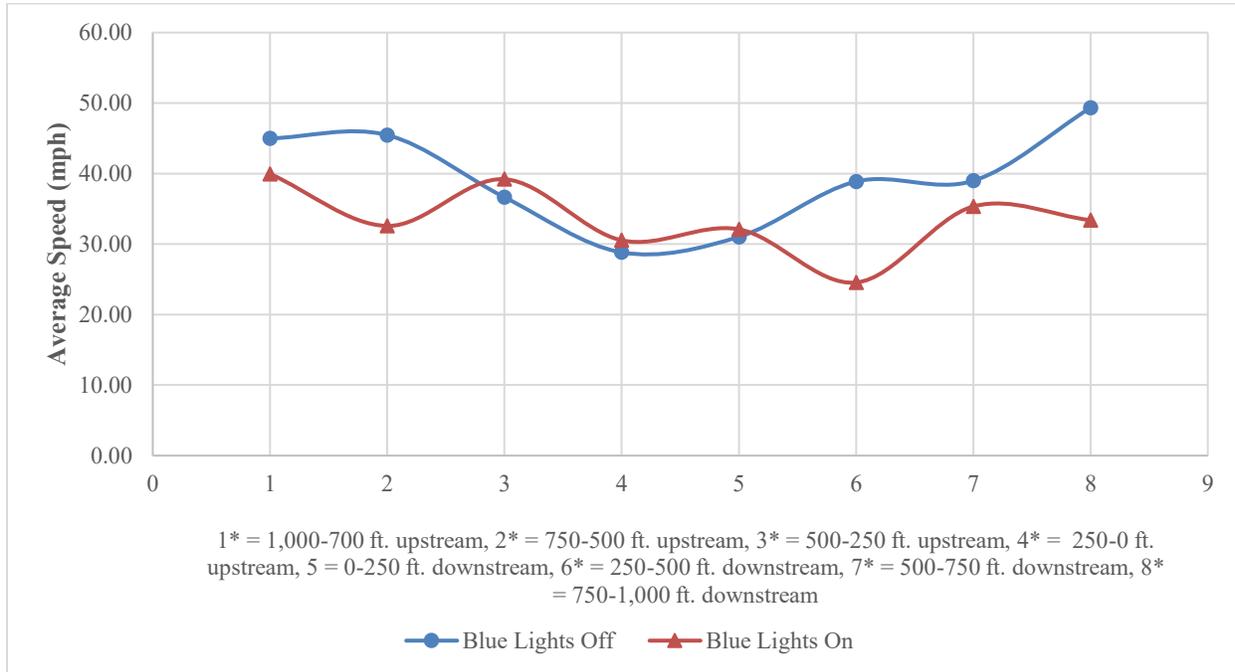
Figure 5.25: Speed distribution across the work zone at 250 ft. intervals (Case Study 1) (* p-value < 0.05)

From this table, it can be observed that while approaching the paver, and after passing by the paver, on days with the blue lights off the mean of the recorded speed values was higher than the mean speed on the days with the blue lights turned on for all intervals except 0-500 ft. upstream and 0-250 ft. downstream of the paver. These differences were statistically significant (p -value < 0.05). However, closer to the paver (0-500 ft. upstream and 0-250 ft. downstream), some differences indicate that on blue lights “on” days, speed was recorded to be higher. However, the higher value was found to be statistically significant (p -value < 0.05) in the 0-250 ft. and 250-500 ft. intervals only (Figure 5.25).

Based on the results, it appears that when a vehicle is 1,000 ft. upstream of the paver, the driver observes the paver with flashing blue lights on and slows down. But, once the driver comprehends that the blue lights are not on a law enforcement or emergency vehicle, the driver speeds up slightly until they pass the paver. Then, shortly after passing the paver, their behavior is normalized and a low average speed is recorded again. However, for the majority of the intervals, at 95% level of confidence, the reductions in mean speed associated with the blue lights turned on were found to be statistically significant.

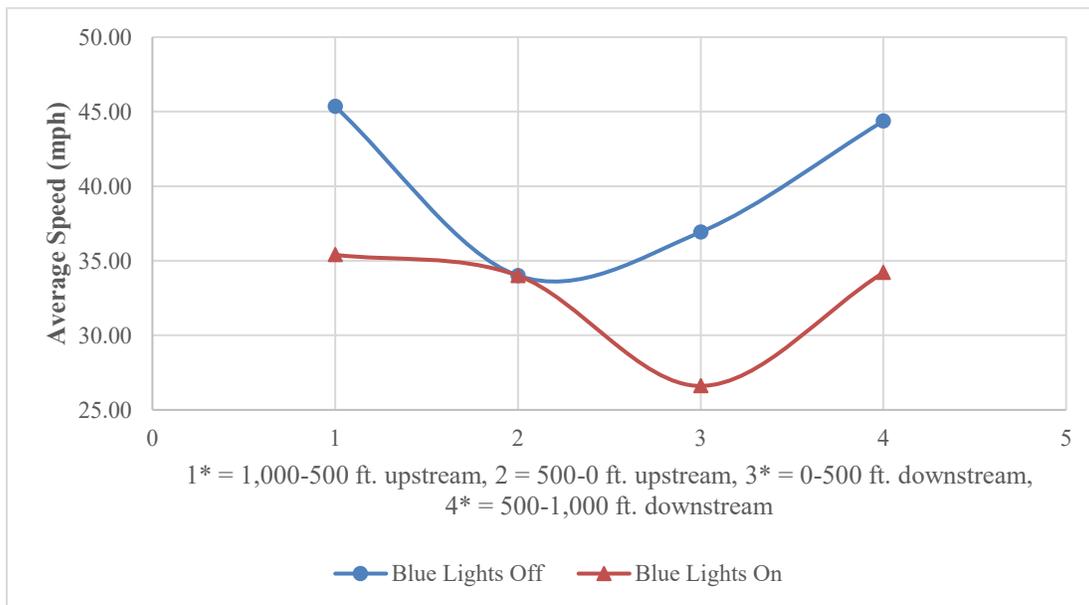
Figure 5.26: Speed distribution across the work zone at 500 ft. intervals (Case Study 1) (* p-value < 0.05)

As further investigation, the same two datasets were used to compare control and treatment based on 500 ft. intervals. The longer interval normalized that dataset and revealed the speed relationships shown in Figure 5.26. In the figure, it can be observed that the average speed recorded on days with the blue lights turned on is always lower than on days with the blue lights turned off except for the location closer to and upstream of the paver (500 to 0 ft. interval). At this location, the difference between the two average speeds is so small that no statistical difference could be observed. However, for the other location intervals, statistically significant reductions of speed were recorded on days with the blue lights turned on (Table 5.4).

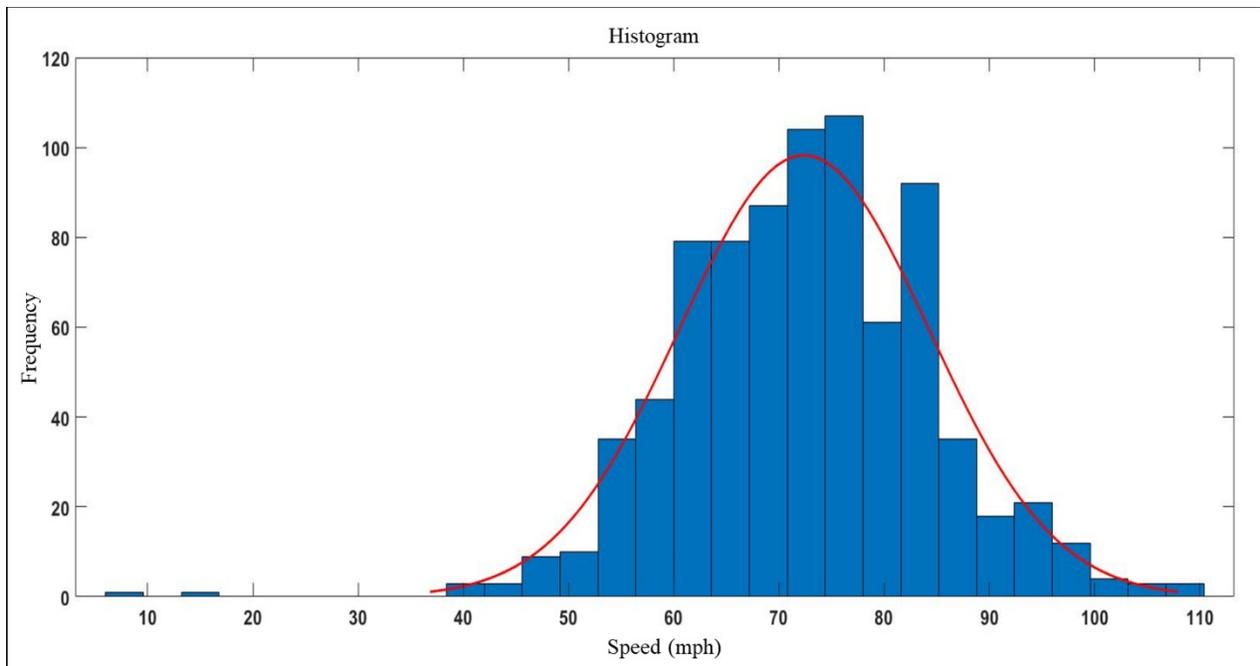
Figure 5.27: Histogram from sensor data at road work ahead sign (Case Study 2)

Similar normality-superimposed histograms were plotted for Case Study 2 located in Grants Pass. Figure 5.27 shows a sample histogram derived from the first sensor at the RWA sign in the A (fast) lane. From the plot shown in Figure 5.7, it can be observed that data is normally distributed. The distribution is shifted slightly towards the right due to the nature of the lane and location of the sensor relative to the active work area (the average speed is higher than in the work zone).

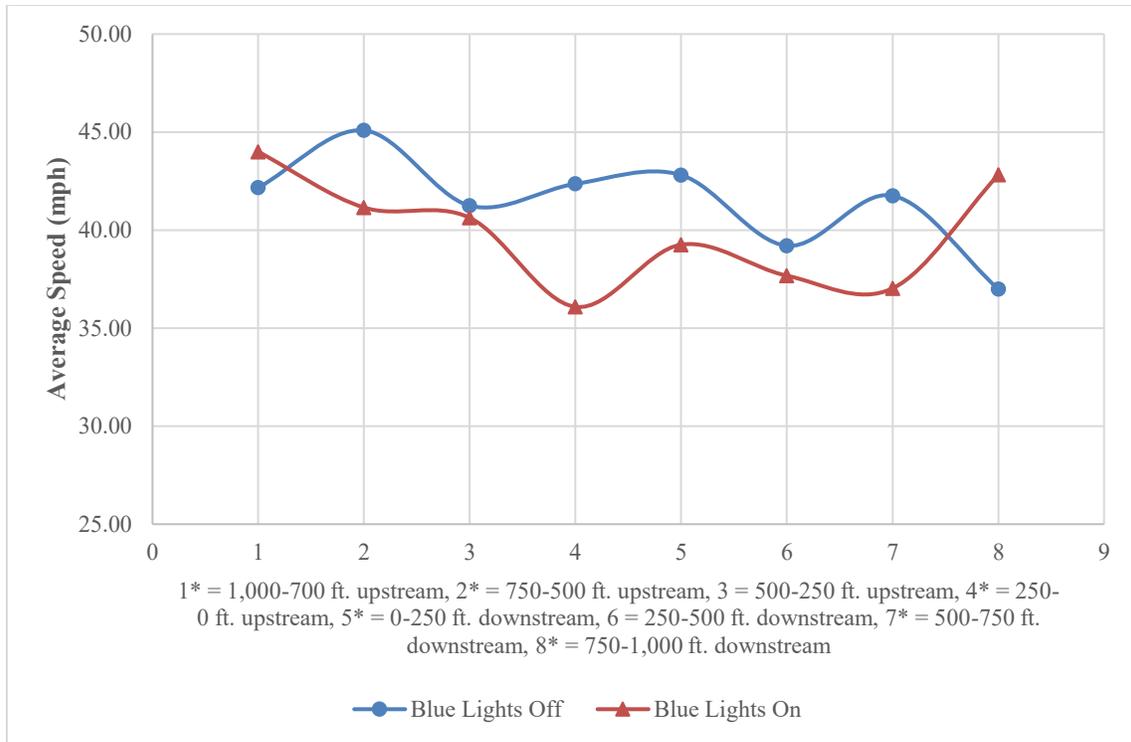
Figure 5.28: Speed distribution across the work zone at 250 ft. intervals (Case Study 2) (* p-value < 0.05)

Case Study 2 showed consistent results from 750 ft. upstream to 750 ft. downstream of the paver. In this range, vehicle speeds for the control days were found to be higher than for the treatment days. Statistically significant differences were found for most of the intervals other than the 500 to 250 ft. range upstream of the paver (Table 5.7). However, the first and last two ranges (1,000 to 750 ft. upstream and downstream) showed opposite results (Figure 5.28). At a statistically significant level, days with the blue lights turned

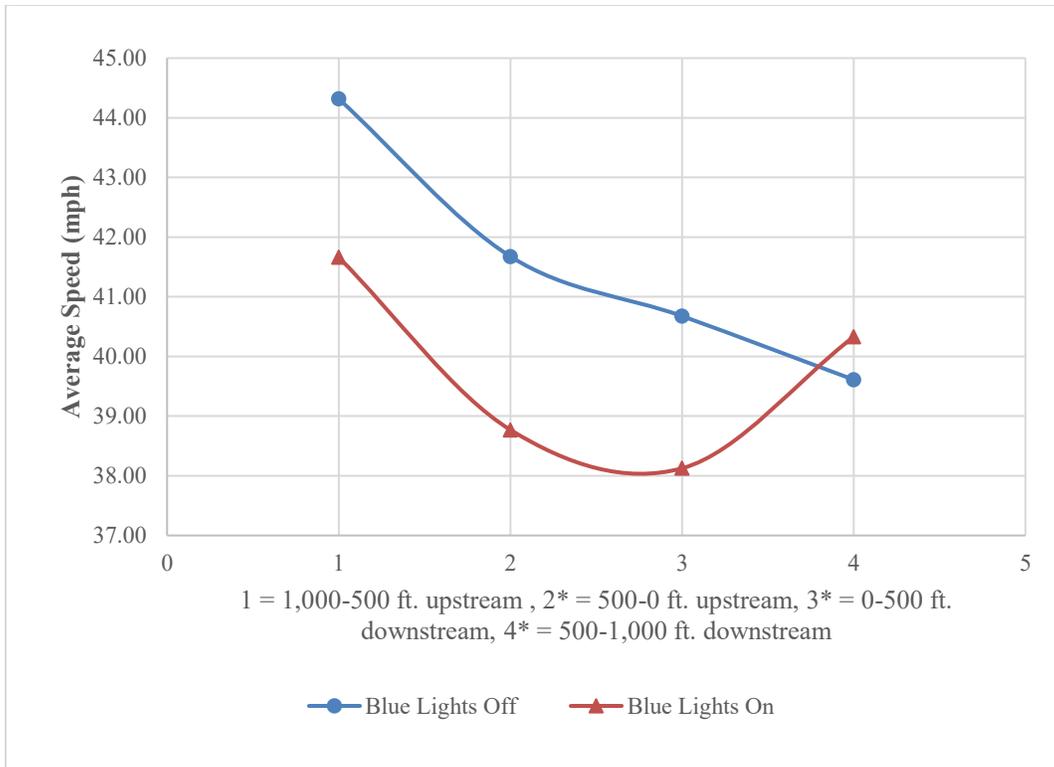
Figure 5.29: Speed distribution across the work zone at 500 ft. intervals (Case Study 2) (* p-Value < 0.05)

To further normalize the effect of the interval, the same analysis was performed with similar assumptions on the dataset and with 500 ft. intervals. The analysis revealed that at all locations other than 500 to 1,000 ft. upstream of the paver, days with the blue lights turned on had statistically significant reductions in speed as seen in Table 5.8. For the last interval location, the difference was reversed; however, this difference was found to be statistically significant as well. After travelling passed the paver, on days with the blue lights turned on (treatment days), the drivers tended to speed up more (Figure 5.29).

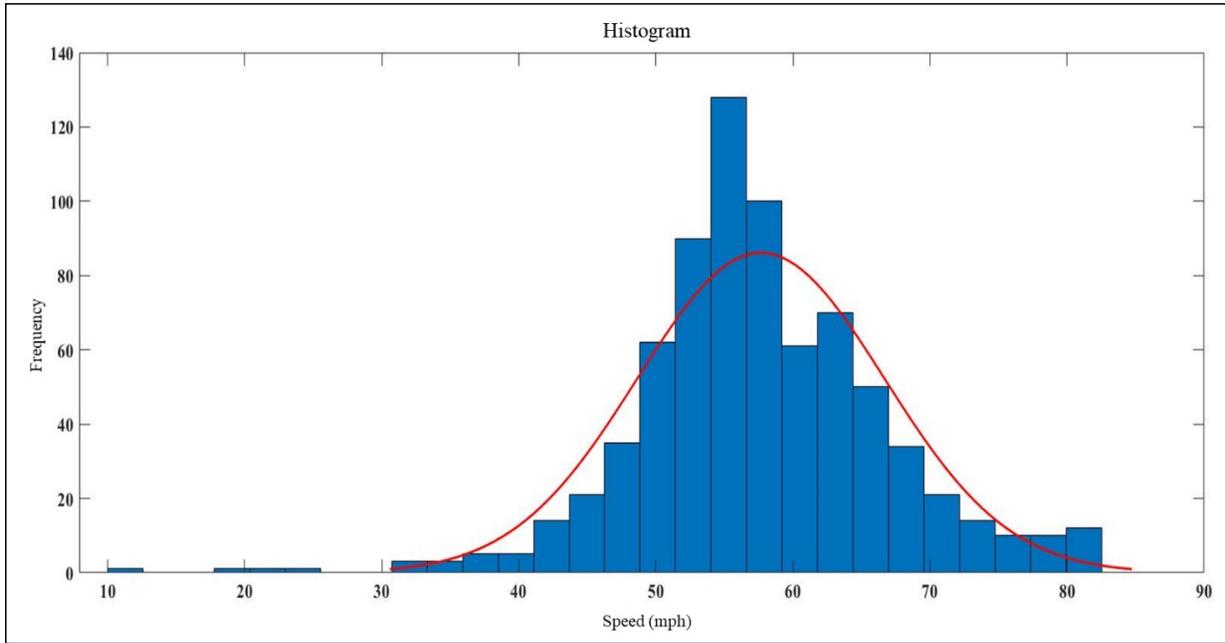
Figure 5.30: Histogram from sensor data at road work ahead sign (Case Study 3)

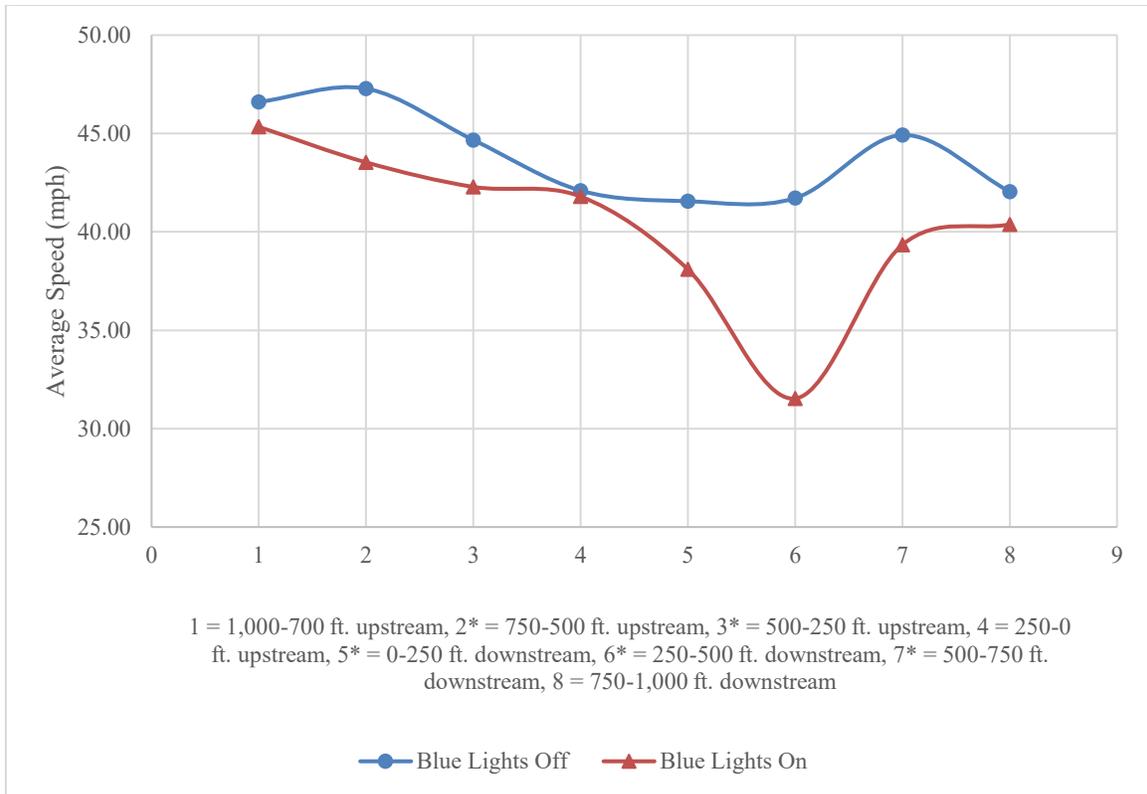
Figure 5.31: Speed distribution across the work zone at 250 ft. intervals (Case Study 3) (* p-value < 0.05)

In Case Study 3, days in which the blue lights were turned off showed a higher recorded average speed across all locations. The differences can be observed in Table 5.11. However, at 1,000 to 750 ft. both upstream and downstream, and 0-250 ft. upstream, even though the differences were higher, the differences were not found to be statistically significant. In the plot shown in Figure 5.31, it can be seen that at close proximity to the paver, drivers did not display highly different behavior in both cases. In addition, with the blue lights on, the rate of increase in vehicle speeds downstream of the paver (already passed paver) appears to be less than with the blue lights off.

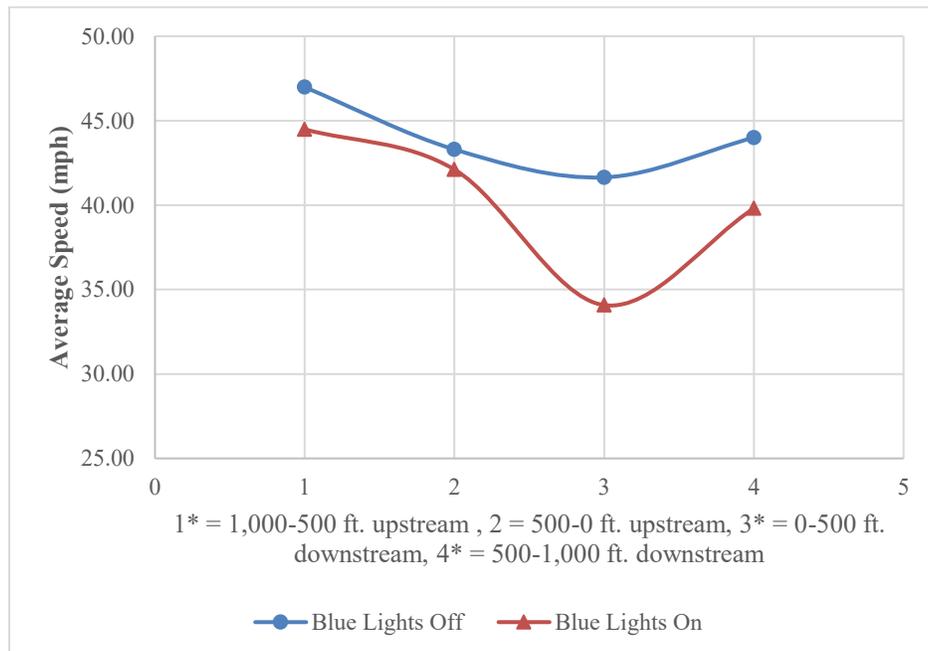
Figure 5.32: Speed distribution across the work zone at 500 ft. intervals (Case Study 3) (* p-value < 0.05)

The same dataset was used to compare the effect of the blue lights at 500 ft. intervals as shown in Figure 5.32. In this case, the larger distance bins have normalized the end effects and both ends (1,000 – 500 ft. both upstream and downstream) show statistically significant difference in speed; on days with the blue lights turned on the speeds were lower than on days with the blue lights turned off (Table 5.12). However, at the location of the paver, significant difference was not observed for this case study as well.
