**QUANTIFYING THE PERFORMANCE
OF LOW NOISE TRANSVERSE RUMBLE
STRIPS**

Final Technical Memo

PROJECT SPR 829A

Oregon Department of Transportation

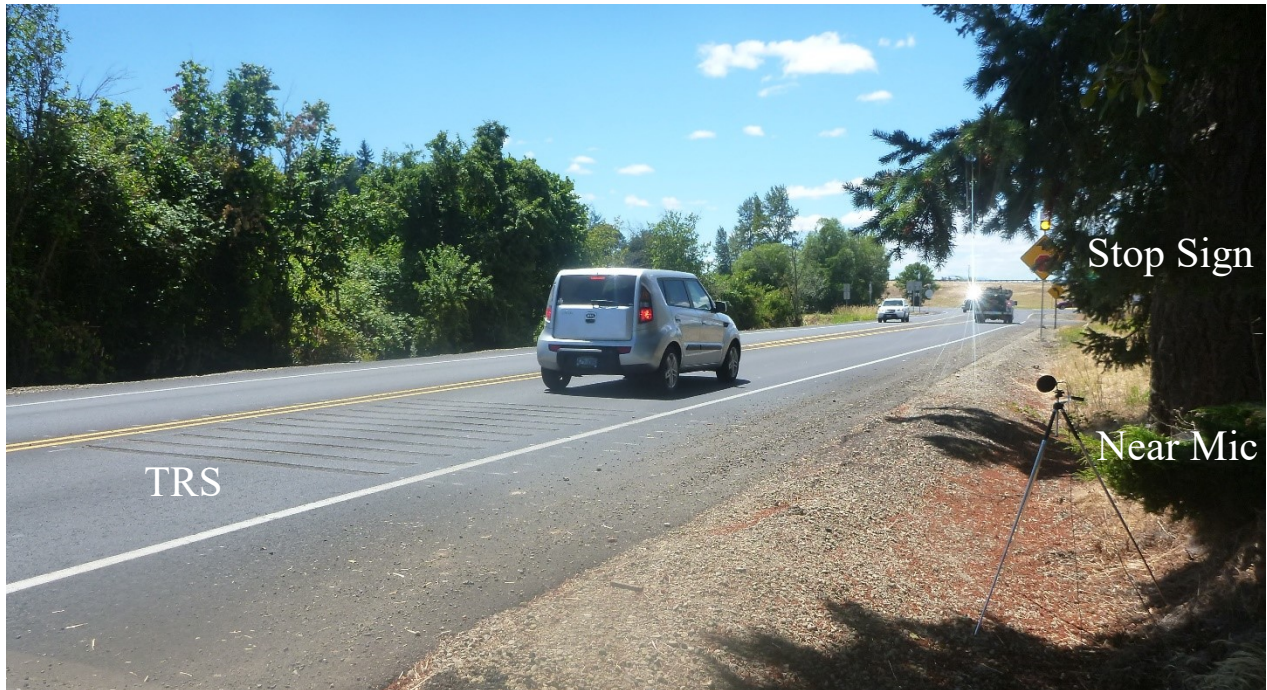
Figure 2.5: Before TRS roadside microphone setup

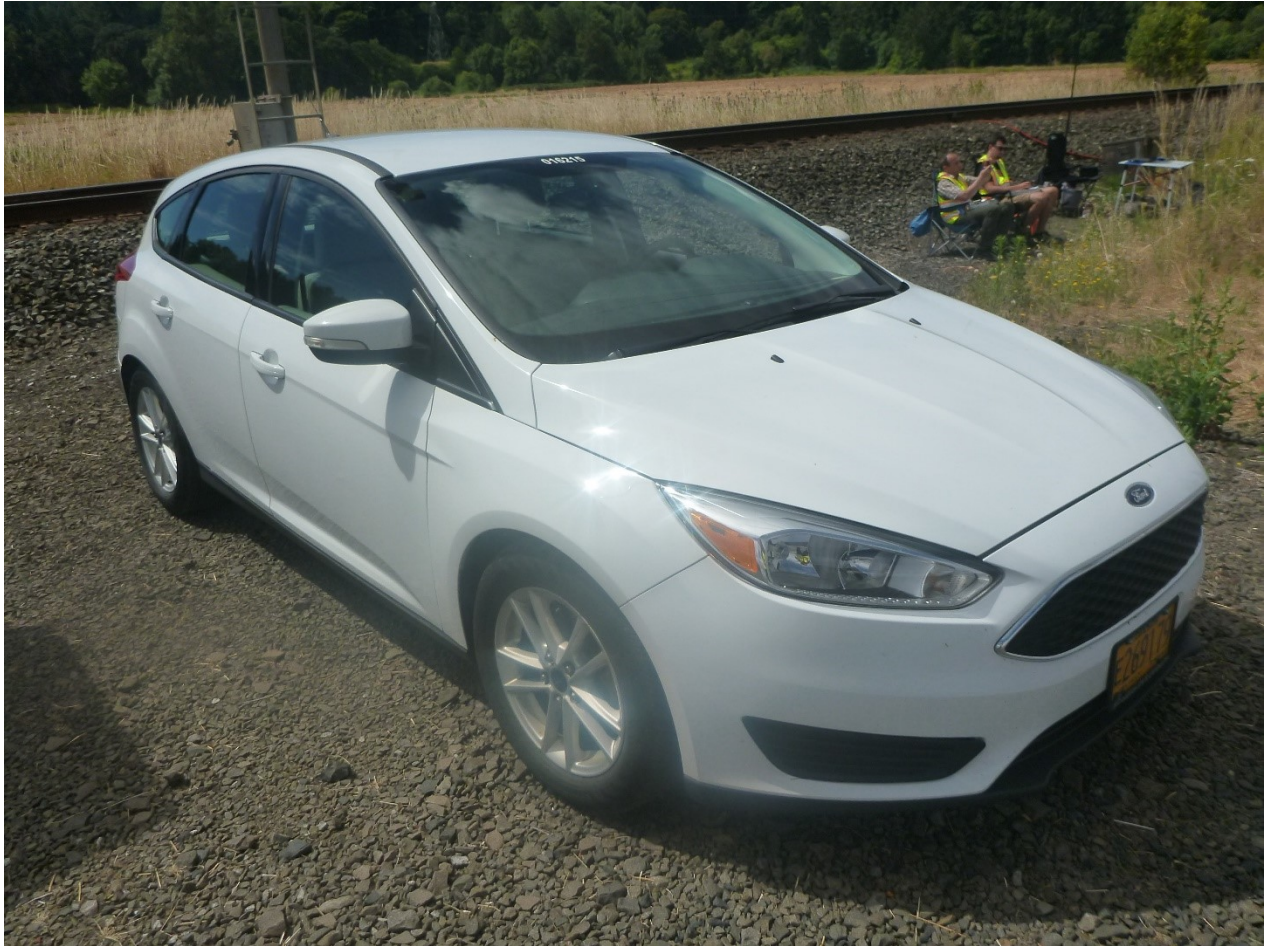
Figure 2.6: Passenger car probe vehicle

A passenger car (Figure 2.6) was rented from Oregon State’s motor pool and driven by licensed graduate research assistants. Drivers were instructed to drive at the posted speed at a safe operating distance from other vehicles on the roadway. Two-way radios were used to communicate between the vehicle assistant and the roadside team at the measurement location. The passenger car was a 2017 Ford Focus Hatchback (license plate number E269179). The tires were Continental ContiProContact 215/55 R 16 93 H. Tire pressures are shown in Table 2.1.

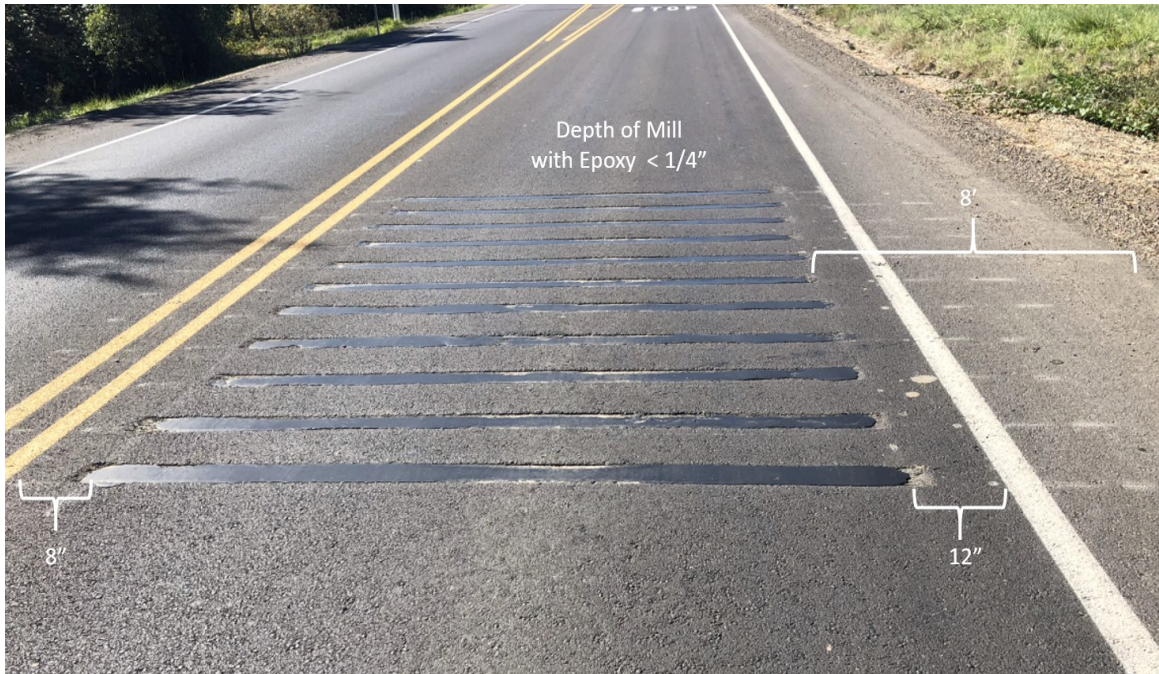
Figure 3.2: After condition: Epoxy filled TRS at near location

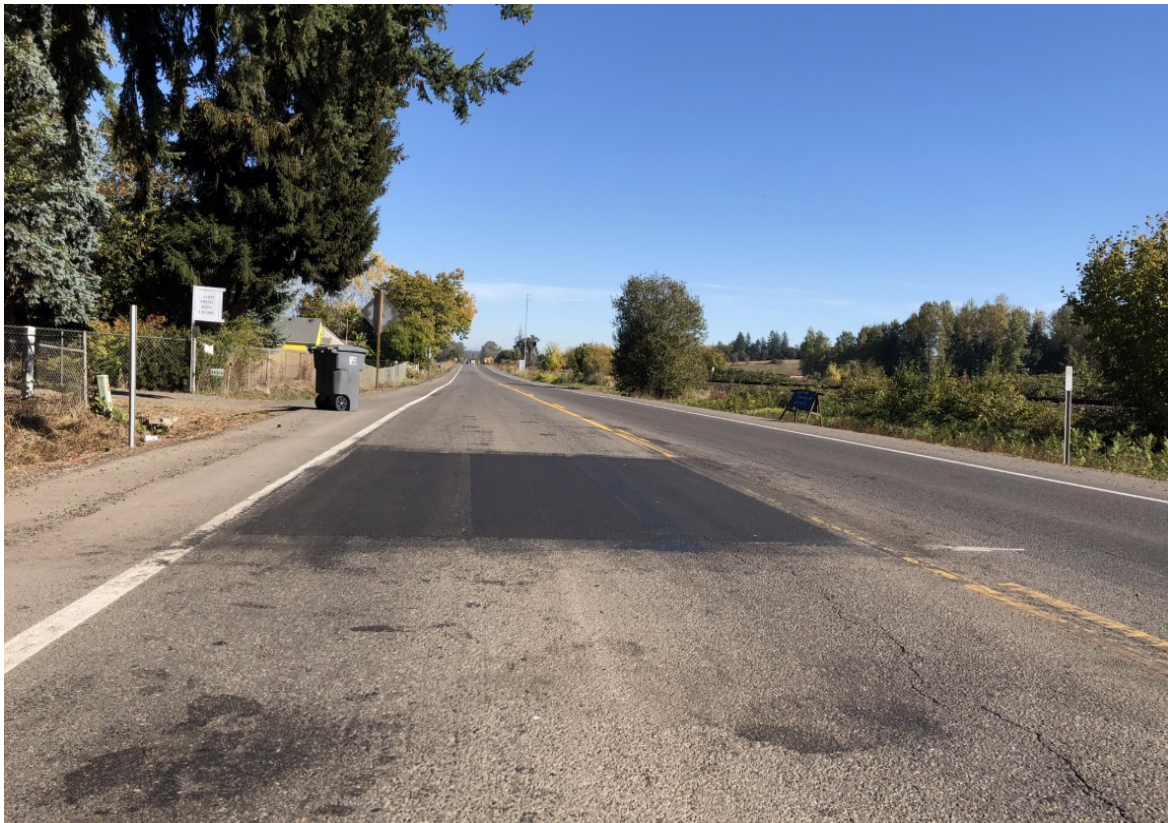
Figure 3.3: After condition: Paved TRS at far location
